Rolling Contact Fatigue of Hot Isostatic Pressed WC-NiCrBSi Thermal Spray Coatings

S.Stewart, R.Ahmed

Heriot Watt University, Edinburgh, Scotland, UK

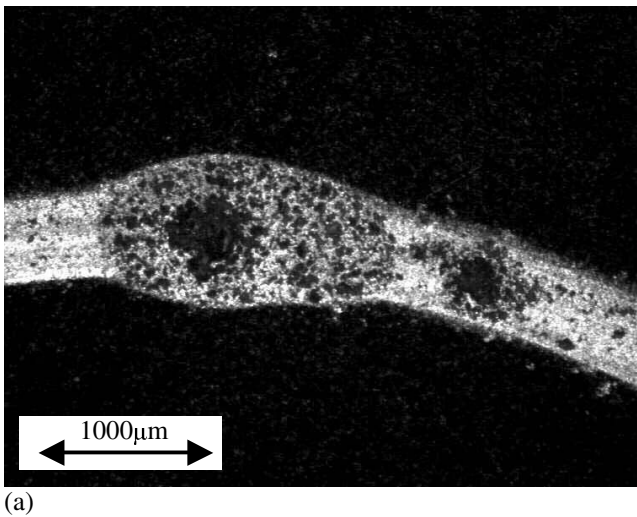
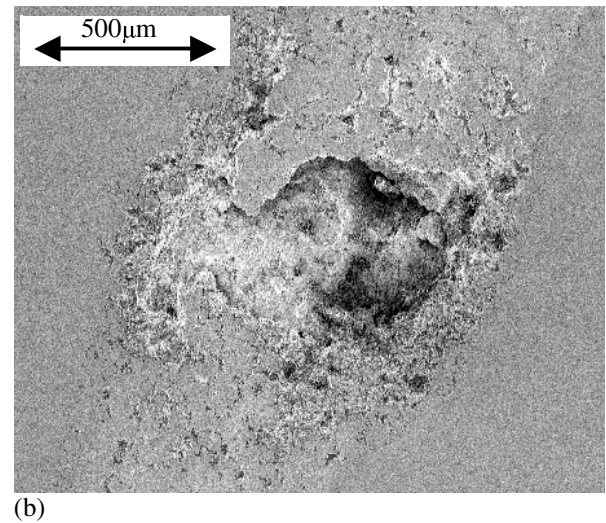
Figure 2 shows the surface of a failed As-Sprayed WC-NiCrBSi disc subjected to a stress of 2 GPa (Test T1). Figure 2(a) shows the area of failure under light microscope while Figure 2(b) is from SEM and displays the area of failure in more detail.

Figure 2: Surface Observation of As-Sprayed WC-NiCrBSi disc (Test T1); (a) overall view of failed area; (b) area of failure at higher magnification.

RCF tests were performed on As-Sprayed WC-NiCrBSi coatings at two different levels of contact stress. Figure 2 shows the surface observation of the failed disc subjected to a stress of 2 GPa. From initial analysis it appears that delamination is the main mode of failure since the area of failure is greater than the width of the wear track. However, with closer inspection it can be seen that failure has resulted

from a spall within the wear track. The debris from this initial spall has formed a high frequency of macropits which surround the spall and also a number of larger pits within the wear track. At a higher contact stress the mode of failure has not changed (Figure 3). The effect of increasing the contact stress has lead to the formation of a more significant spall which in turn has lead to more macro pits forming from the subsequent increase in volume of debris from the initial spall.

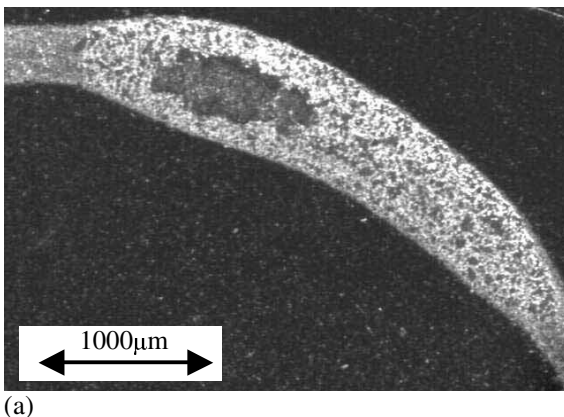
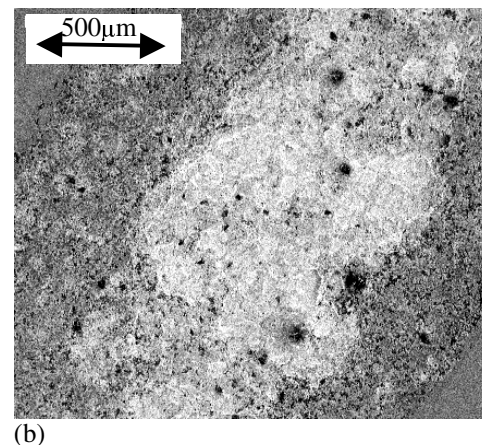
Figure 3. shows the surface observation of an As-Sprayed disc subjected to a higher contact stress of 2.7 GPa (Test T2). Figure 3(a) shows an overall view of the area of failure. Using SEM, Figure 3(b) gives a more detailed image of the failure.

Figure 3: Surface Observation of As-Sprayed WC-NiCrBSi disc (Test T2); (a) overall view of failed area; (b) area of failure at higher magnification.

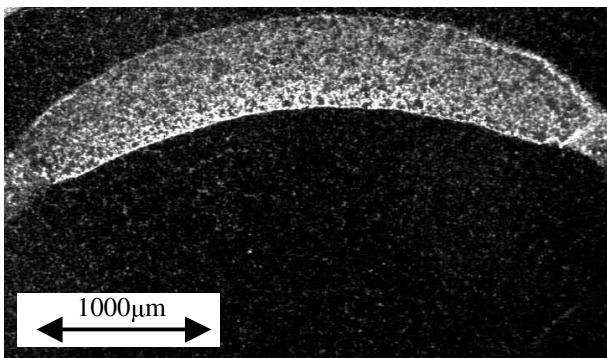
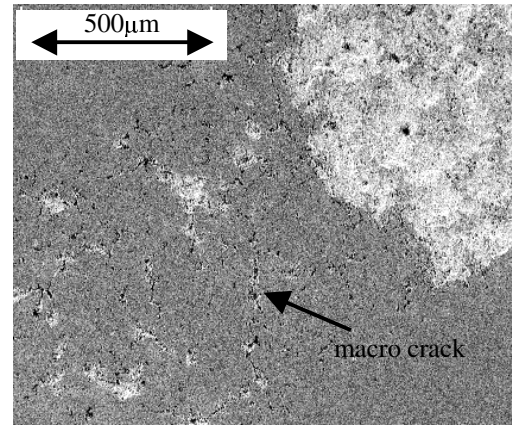
Figure 4 shows the surface observation of an As-Sprayed disc also subjected to a stress of 2.7 GPa (Test T3). However, the planetary balls are now ceramic. Figure 4(a) shows the surface observation. Under closer inspection a number of cracks can be detected near the pit and are located in the centre of the wear track (Figure 4(b)).

Figure 4: Surface Observation of As-Sprayed WC-NiCrBSi disc (Test T3); (a) overall view of failed area; (b) edge of failure and macro cracking in wear track.

Figure 3 shows the surface observation of a failed WC-NiCrBSi disc subjected to a stress of 2.7 GPa using ceramic planetary balls. A number of macro cracks are visible using SEM near the area of failure. Under Light Microscope the area of failure appears to be delamination but with closer inspection the area of failure has formed from a high frequency of macro pits. It is highly likely that the formation of the macropits were initiated from the macro cracks within the wear track.

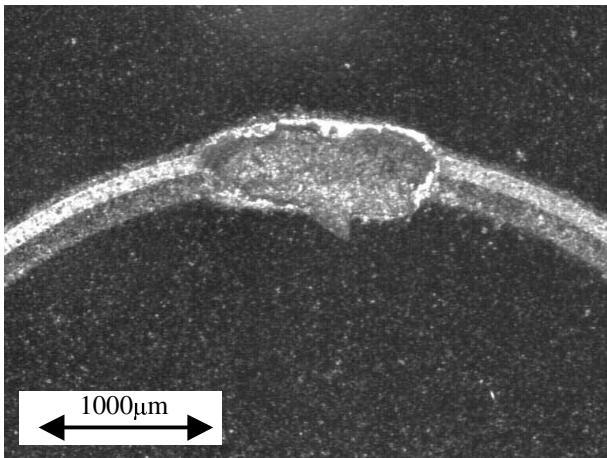
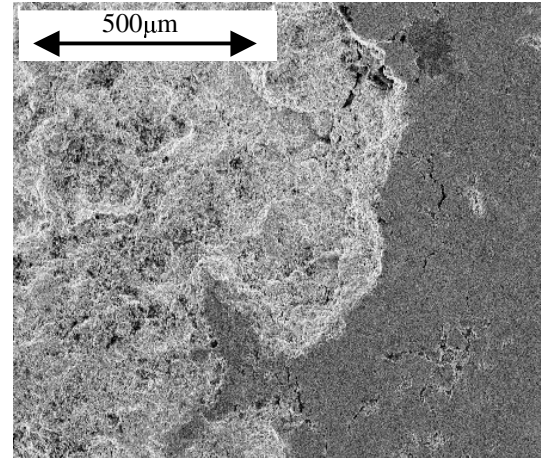
Figure 5. shows the surface observation of a failed coated disc which was HIPed at 1123K and subjected to a contact stress of 2.7 GPa using steel planetary balls (Test T5). Figure 5(a) shows the area of failure which has spread outwith the confines of the wear track. The steep walls of the pit, which can be observed at higher magnification, indicate significant depth (Figure 5(b)).

Figure 5: Surface Observation of HIPed at 1123K WC-NiCrBSi disc (Test T5); (a) overall view of failed area; (b) edge of pit at higher magnification..

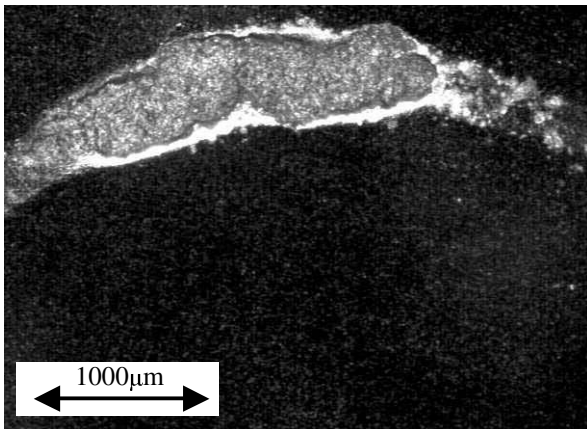
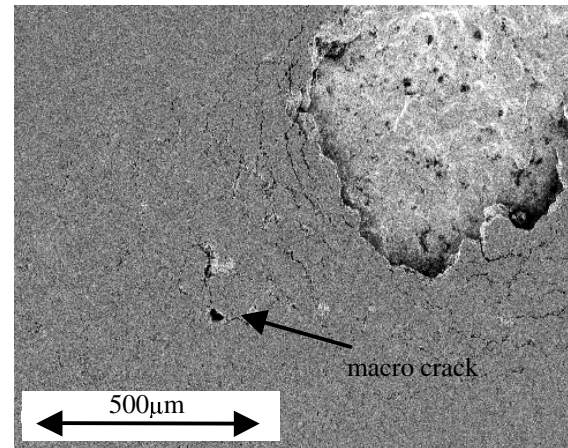
Figure 6, shows the surface observation of a failed disc also HIPed at 1123K and subjected to a contact stress of 2.7 GPa (Test T6). The planetary balls were ceramic. Figure 6(b) shows the formation of a significant pit which has spread out with the wear track. Figure 6(b) shows evidence of macro cracks forming within the centre of the wear track near the area of failure.

Figure 6 shows the surface observation for a failed disc HIPed at 1123K and subjected to a stress of 2.7 GPa. The effect of HIPing has changed the mode of failure. A significant pit has formed and spread out with the wear track. The walls of the pit are relatively steep indicating significant depth. From these characteristics, the mode of failure is concluded to be delamination. It is highly likely that failure was initiated by subsurface defects but this theory will require confirmation from sub surface analysis.

Figure 6: Surface Observation of HIPed at 1123K WC-NiCrBSi disc (Test T6); (a) overall view of failed area; (b) edge of pit at higher magnification.

Figure 6 shows the surface observation of a failed disc HIPed at 1123K tested under identical conditions. It can be seen that the mechanism of failure has changed. A pit has formed with steep sides and significant surface area. The mode of failure was concluded to be delamination. A number of macro cracks were also visible near the area of failure.

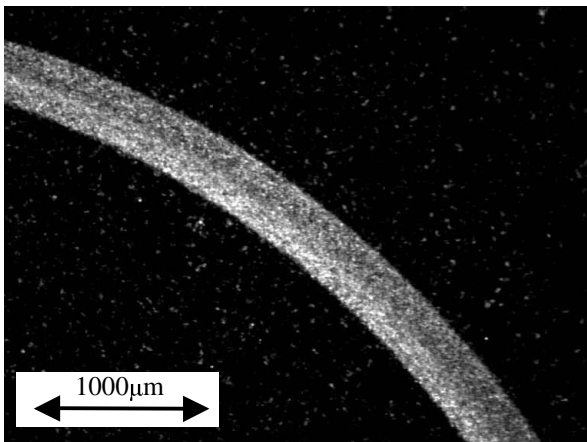
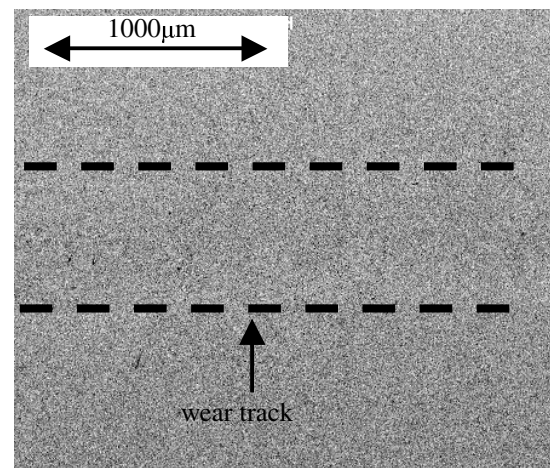
Figure 7 shows the surface observation of a unfailed coated disc HIPed at 1473K and subjected to a stress of 2 GPa using steel planetary balls (Test T7). Figure 7(a) shows the wear track at low magnification. Figure 7(b) shows the wear track failure at higher magnification

Figure 7: Surface Observation of HIPed at 1473K WC-NiCrBSi disc (Test T7); (a) overall view of wear track; (b) wear track at higher magnification..

Figure 7 shows the wear track of a disc HIPed at 1473K and subjected to a stress of 2 GPa.using steel planetary balls. NO failure was detected by either light microscopy or SEM analysis. This is an important result since it shows that when functionally graded WC-NiCrBSi coatings are exposed to high temperatures during HIPing significant improvement in resistance to rolling contact fatigue occurs.

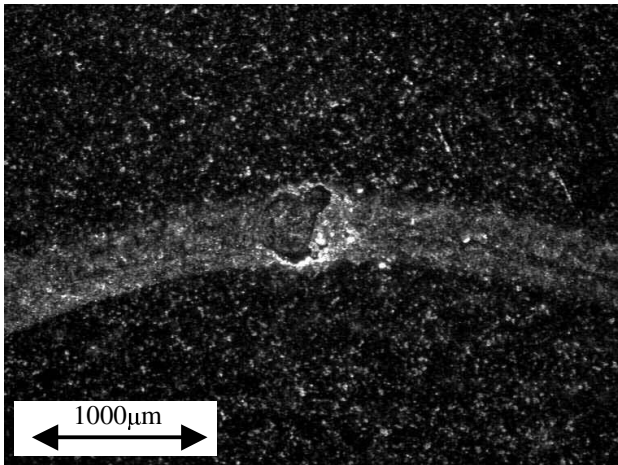
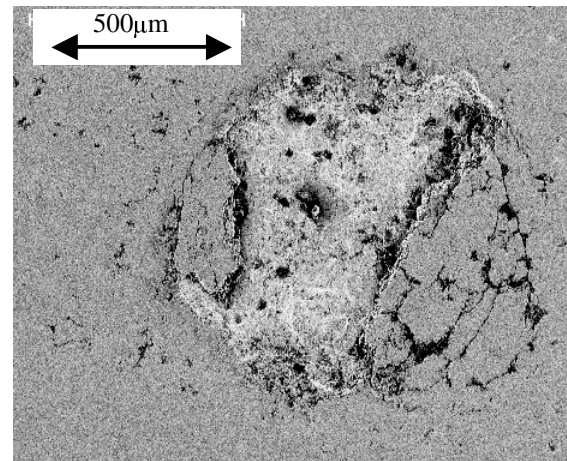
Figure 8 shows the surface observation of a failed coated disc HIPed at 1473K and subjected to a stress of 2.7 GPa using steel planetary balls (Test T8). Figure 8(a) shows that the area of failure was within the wear track. Figure 8(b) shows the area of failure at higher magnification.

Figure 8 shows the surface observation for a failed disc HIPed at 1473K and subjected to a stress of 2.7 GPa. It can be seen that the mode of failure has changed in increasing the HIPing temperature. The pit which has formed is smaller in size and is restricted to within the wear track. Under higher magnification the sides of the pit appear relatively steep and the bottom of the pit is flat. These characteristics suggest that in fact the pit is a spall. It is highly likely that failure initiated from a surface defect since Microhardness and Elastic Modulus results aswell as previous investigations on the

coating microstructure [8] rule out the possibility of sub surface defects.

Figure 8: Surface Observation of HIPed at 1473K WC-NiCrBSi disc (Test T8); (a) overall view of failed area; (b) area of failure at higher magnification..

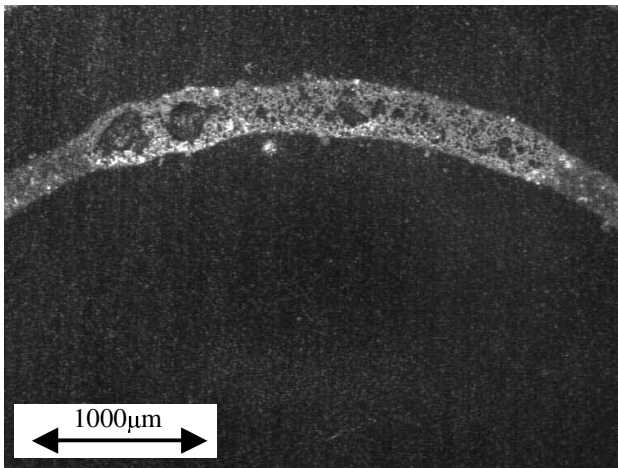
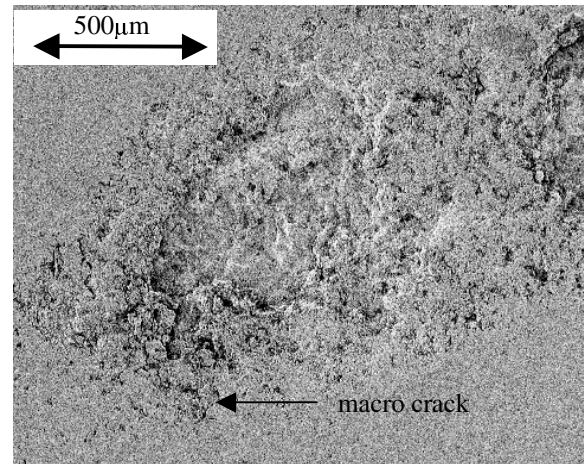
Figure 9. shows the surface observation of a failed disc HIPed at 1473K and subjected to a stress of 2.7 GPa using ceramic planetary balls (Test T9). Figure 9(a) displays the overall view of failure. Figure 9(b) shows a number a macro cracks near the area of failure and at the centre of the wear track.

Figure 9: Surface Observation of HIPed at 1473K WC-NiCrBSi disc (Test T9); (a) overall view of failed area; (b) area of failure at higher magnification..

Figure 9. shows the surface observation of a failed disc HIPed at 1473K and subjected to a stress of 2.7 GPa using ceramic planetary balls. It can be seen from both the SEM and Light Microscope images that the mode of failure is no longer delamination. Failure has resulted from the formation of a spall within the wear track. The debris from the initial spall has formed subsequent macro pits and dents within the wear track. The SEM image shows a number of macro cracks near the spall. It is highly likely that these cracks initiated the formation of the initial spall.
