Surface and Coatings Technology 172 (2003) 204-216

Contact fatigue failure modes in hot isostatically pressed WC-12%Co coatings

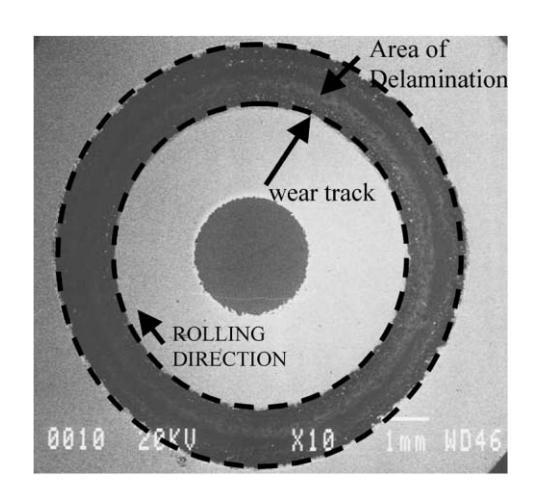
Post-analysis of the wear tracks using SEM and light microscopy displayed some interesting features. In Fig. 2 the wear track of the as-sprayed rolling element T2 is highlighted. No area of failure was observed. In Fig. 3 the wear track of the as-sprayed rolling element T3 was observed in greater detail using SEM. Fig. 4 and Fig. 5 displays the wear track of the rolling element T4. The coated rolling element was HIPed at 850 °C. An area of failure can be seen on the part of the wear track. Fig. 6 display the wear track of rolling element T6. Similar to the rolling element T5, the area of failure which was formed on part of the wear track has spread out with the confines of the wear track. In Fig. 7 and Fig. 8 the area of failure is shown in greater detail. No failure area was seen on the wear track of rolling element T7 (Fig. 9). However under higher magnification, evidence of abrasive pitting was seen within the wear track (Fig.

Fig. 2. Wear track after test T2.

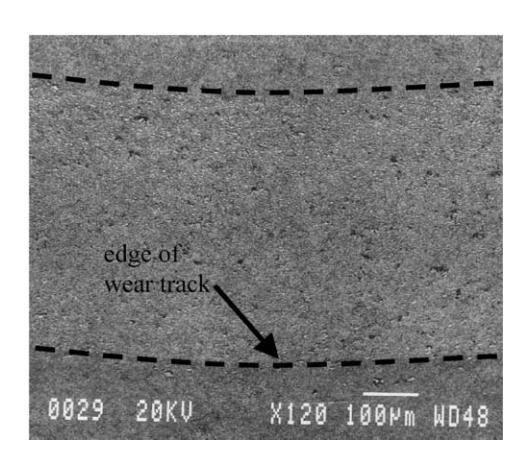
Fig. 3. Wear track after test T3.

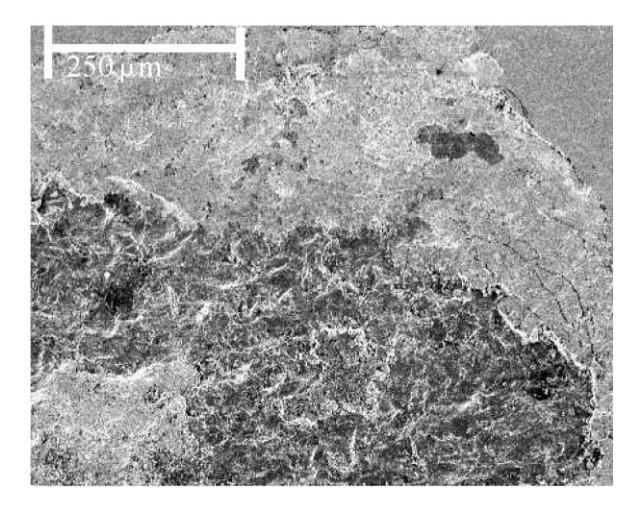
Fig. 5. Delamination on wear track T4.

In test T4 where the coating thickness was again such that the coating/substrate interface was at the location of the maximum shear stress it is likely that failure occurred for the same reasons as the as-sprayed coating of identical thickness, since no improvement in the microstructure was observed after HIPing.

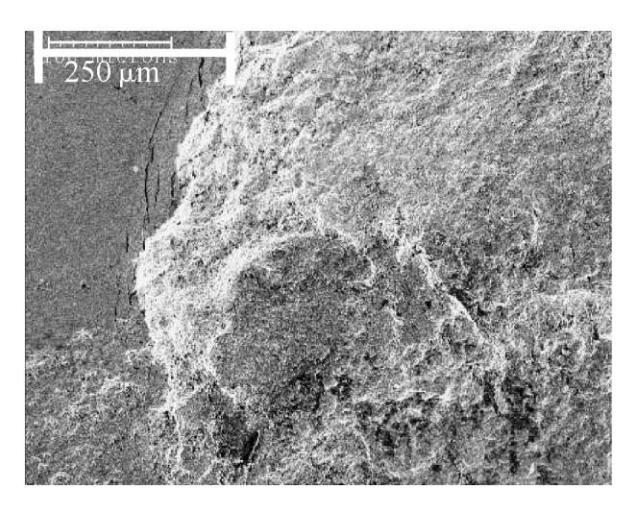
Fig. 8. Delamination on wear track T6.

In tests T5 and T6 the location of the maximum shear stress was moved away from the coating/substrate interface, however, failure was still shown to occur by delamination and after a relatively small number of stress cycles. In comparing the microstructure of the assprayed coatings (Fig. 15) and coatings HIPed at 850 °C (Fig. 16), it can be seen that the pores in the HIPed coating are in general slightly greater in size. Pores in thermal spray coatings can arise from the expansion of trapped gases. These pores are normally spherical in shape. HIPing has been shown in previous investigations to remove these pores by a complex process [13]. HIPing leads to hot plastic deformation which causes the columnar grains to be broken into pieces forming many substructures and crystal defects within the grains. At elevated temperatures recrystallization takes place in these regions which contain substructures and crystal defects decreasing the system energy. After grain refinement either by static or dynamic recrystallization the newly formed equiaxed grains are very small due to incomplete grain growth. Under high isostatic pressure for at least an hour these grains will be compressed thus eliminating the pores. It is highly likely that the HIPing temperature of 850 °C was not high enough to cause this microstructural change, but instead the entrapped gases within the pores caused crack propagation to occur at the edges of these pores. During RCF testing, these pores and cracks at the edges of the pores would have acted as stress concentration points when combined with cyclic stresses which leads to failure by delamination.

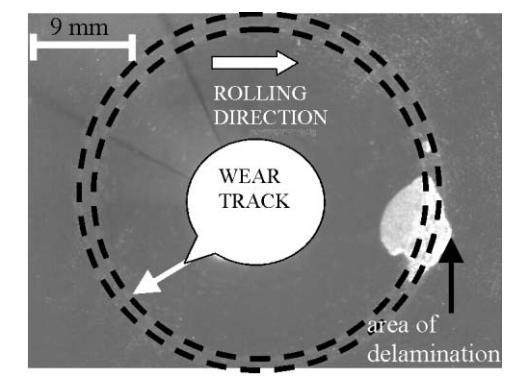
Fig. 6. Wear track after test T6.

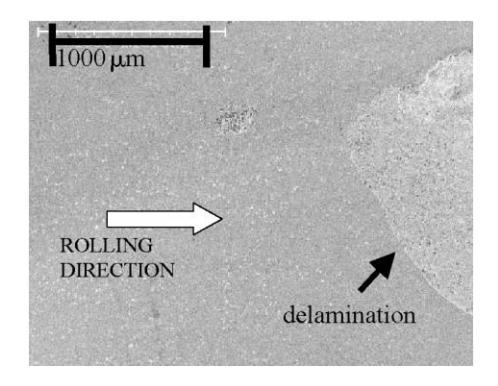
Fig. 7. Delamination on wear track T6.

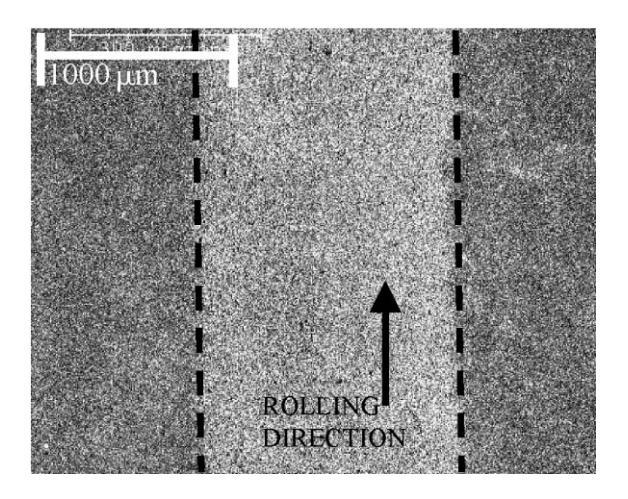
Fig. 9. Wear track after test T7.

In the RCF testing of the coatings HIPed at 1200 °C, a very important result was obtained. In test T7, the coating of 50 μ m thickness endured 70 million stress cycles without failure. In comparison with both coatings which were as-sprayed and HIPed at 850 °C, there is a significant improvement in resistance to rolling contact fatigue failure. The reason for this improvement can be related to significant changes which have occurred at the coating/substrate interface (Figs. 17–19). The location of maximum shear stress in test T7 was in the region of the coating/substrate interface. In tests on coatings of identical thickness in as-sprayed and HIPed at 850 °C state (tests T1 and T5), failure was attributed to the initiation of crack propagation as a result of the location of maximum shear stress combined with cyclic

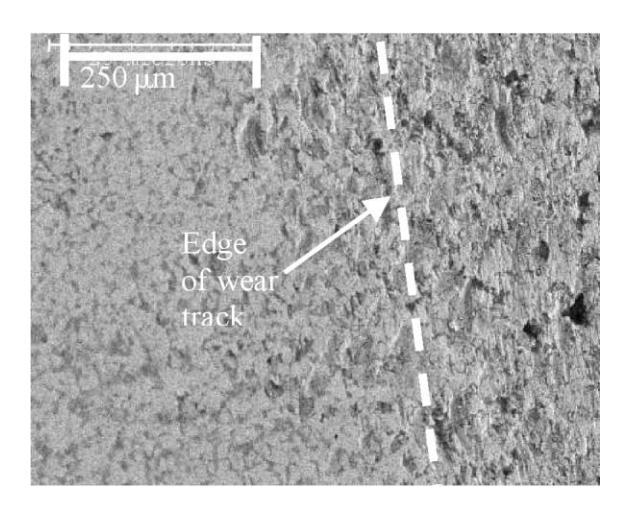
10). This is termed surface distress and is identified by a number of microspalls which run together in a rough pebbly surface. In Fig. 11 a number of dents can be seen on the wear track. They are identified by a characteristic paddle shape, with an extending narrow neck. Surrounding the dents is evidence of localised surface distress, which is identified by a high frequency

Fig. 10. Wear track after test T7.

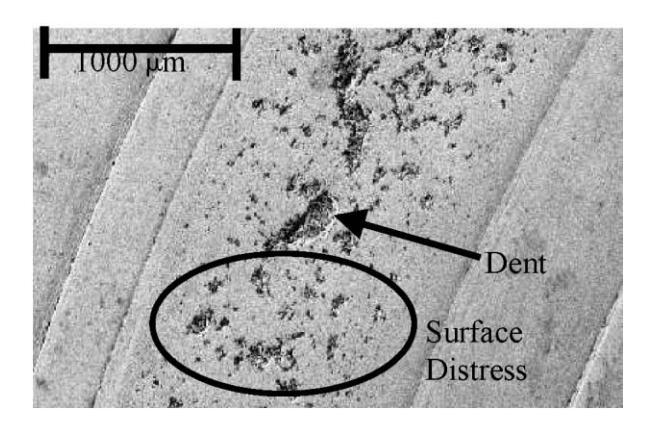
Fig. 11. Surface abrasion on wear track T8.

In test T8 the coating endured a significant number of stress cycles before the test was automatically terminated due to an increase in vibration. Surface analysis of the wear track by SEM revealed a number of dents surrounded by a high frequency of smaller craters (Fig. 11). This type of failure was termed Denting. The larger marks have been identified as soft particle dents and result from entrapment of soft material (steel planetary balls) which deforms under the contact pressure. Entrapment of soft material occurs due to asperity contact. The R.M.S. parameter of surface roughness did not take into account peak to valley roughness. Hence, some asperites are much higher than the stated R.M.S. value which results in localised film thinning. Since the coating is essentially incompressible, the soft material forms dents in the coating since the Hertzian contact configuration and EHL film allows them no escape. The formation of a dent in full regime may locally depressurise the film resulting in a local film thinning round the dent edges. Asperity interactions occurred producing a local surface distress, which is termed a halo decorating the dent. It was therefore concluded that the increase in vibration during testing was from the high frequency of dents and surface distress within the wear track.

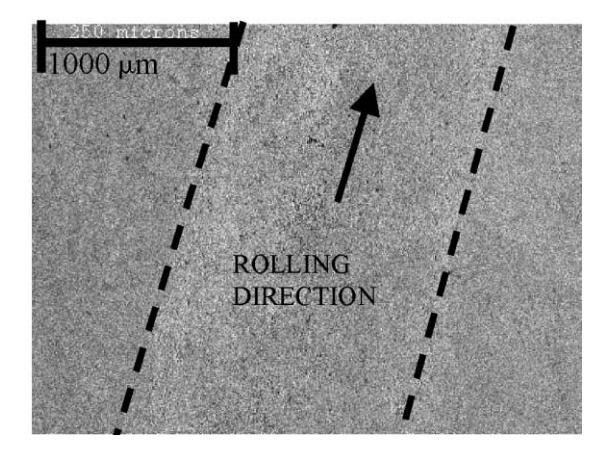
Fig. 12. Wear track after test T9.

of small shallow craters which are a result of asperity contact. Evidence of surface distress within the wear track can also be seen in Figs. 12 and 13 which shows

In test T9 the coating endured 70 million stress cycles without an increase in vibration during RCF testing. From initial surface observation, no failure in the wear track was observed (Fig. 12). However, under higher magnification a number of abrasive marks were observed within the wear track (Fig. 13). These marks were attributed to surface distress. It can be concluded that surface distress formed after a significant number of stress cycles and was a result of decreasing EHL film thickness enabling asperity contact. Depressions in the wear track, formed by high Hertzian contact load locally depressurised and thinned the lubricant film.

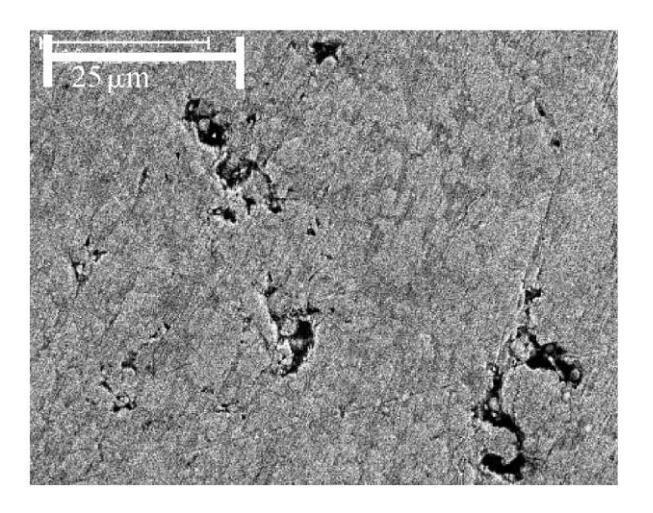
Fig. 14. Microstructure of T3.

All tests on the coating, HIPed at 850 °C were prematurely terminated as a result of surface failure (Table 2). From surface analysis it was observed that failure was by delamination since the area of failure has spread beyond the width of the wear track (Figs. 4–8). Cross-sectional analysis of the coating indicated relatively high porosity within the microstructure (Fig. 15) and like the as-sprayed coating, (Fig. 17) there was no evidence of diffusion into the coating microstructure which has been shown to occur after HIPing [13]. There was also no evidence of recrystallization or interlamellar bonding.

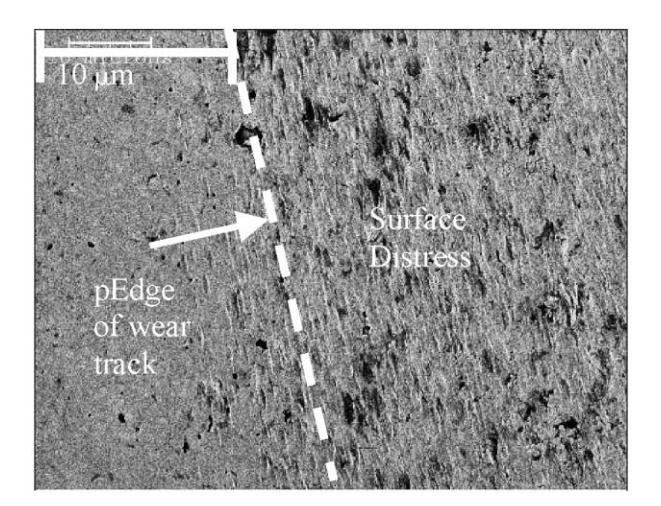
the wear track of T9 at higher magnification and is similar to the wear track of T7.

Fig. 13. Wear track after test T9.

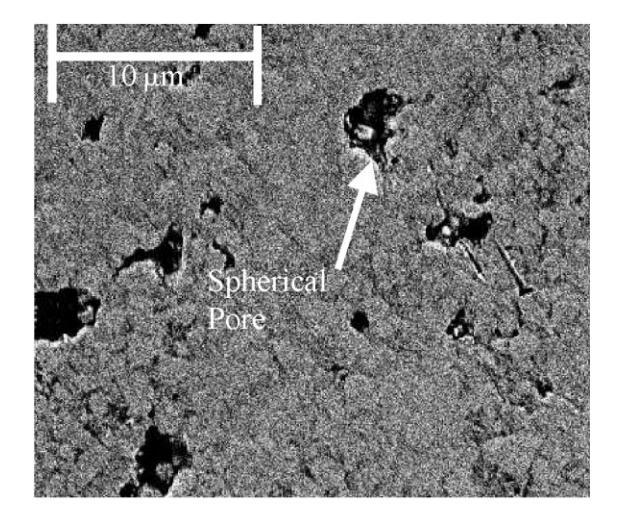
Fig. 15. Microstructure of T5.

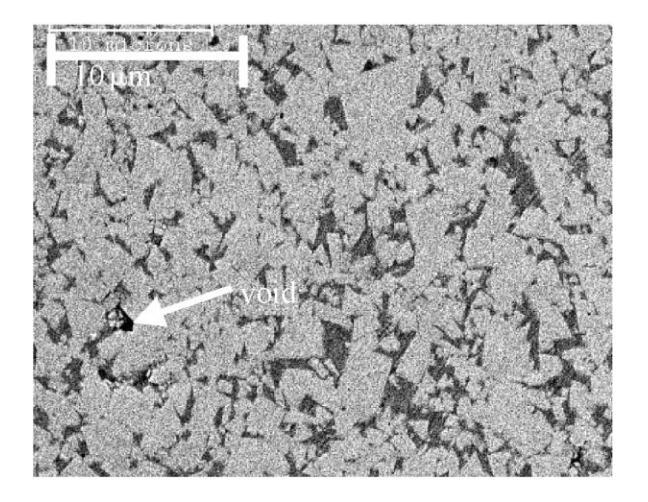
Fig. 16. Microstructure of T8.

the microstructure of the coated rolling element T8 which was HIPed at 1200 °C. The microstructure has lost all of its lamellar or splat morphology and densification has increased considerably with only a small frequency of microvoids appearing within the microstructure.

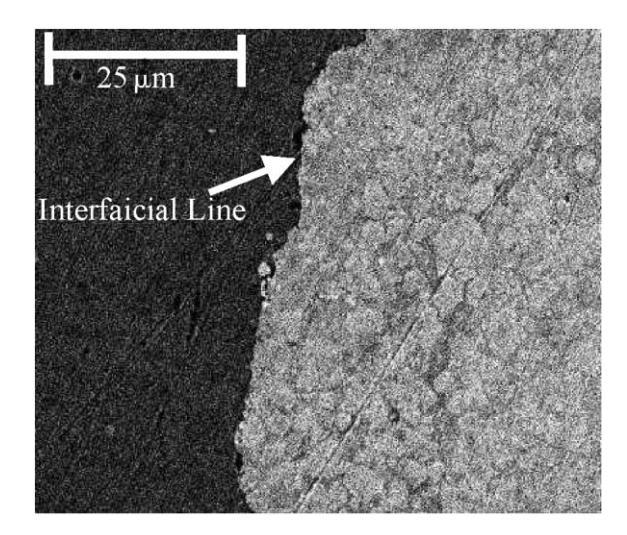
It was important to study the effect of HIPing on the coating/substrate interface. Fig. 17 shows the cross section of the as-sprayed rolling element cone T1. A definite interfacial line can be seen between the coating and the substrate which is a result of shot blasting the surface of the substrate prior to thermal spraying. At HIPing temperatures of 850 °C the interfacial line still exists (Fig. 18). However, the coating/substrate interface at elevated HIPing temperatures has changed considerably (Fig. 19). No interfacial line can now be seen as a result of inter-diffusion between the coating and the

Fig. 17. Interface of As-Sprayed Coating.

stresses during RCF testing which led to failure by delamination after enduring less than a million stress cycles. In comparing the coating/substrate interface of the as-sprayed coating (Fig. 17) and HIPed at 1200 °C coating (Fig. 19), a number of differences were observed. At the coating/substrate interface in the assprayed coatings (Fig. 17) and at lower HIPing temperatures (Fig. 18), an interfacial line can be clearly seen. This interfacial line was formed by shot blasting the substrate prior to thermal spraying to improve mechanical interlock between the coating and the substrate. However, with the onset of diffusion between the coating/substrate at higher HIPing temperatures due to the Kirkendall effect, this line has been removed. It can also be seen that a number of pores have been formed within the substrate close to the interface. These are known as Kirkendall voids which are a result of the diffusion process between the coating and substrate which occurs at high HIPing temperatures. A difference in the rate of diffusion between the coating and the substrate leads to unequal fluxes of the two species from different directions. This type of unequal diffusion requires a defect mechanism. Therefore, as the substrate diffuses into the coating, an excess of vacancies are formed, which later become pores. It is therefore deduced that thermal interlocking between the coating and substrate suppressed crack propagation being initiated at the coating/ substrate interface in test T7. However, it must be emphasised that further studies are required to investigate the diffusion mechanisms and crystallite phases, in order to fully appreciate this improvement at the coating/substrate interface.

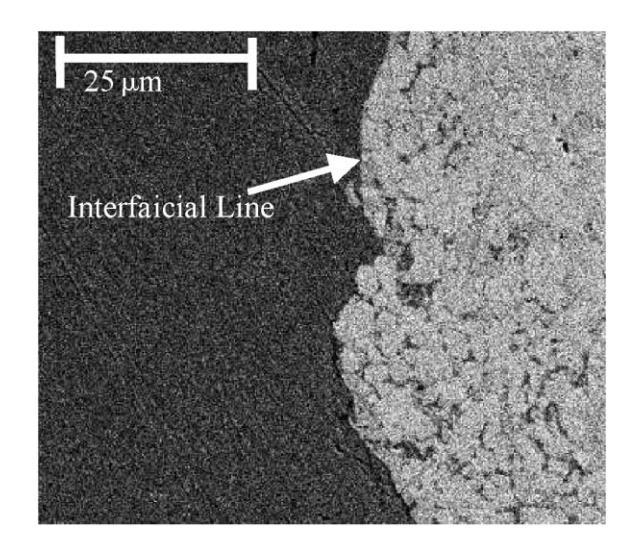
Fig. 18. Coating/substrate interface of T5.

substrate. A number of pores have appeared within the substrate, close to the interface. These pores are Kirkendall voids which are related to the diffusion process. The Kirkendall effect was cited in earlier investigations on diffusion of coatings by Dunand [18]. It gives the names to these pores and describes the phenomenon caused by two chemical species (coating, substrate) diffusing in opposite directions at different rates

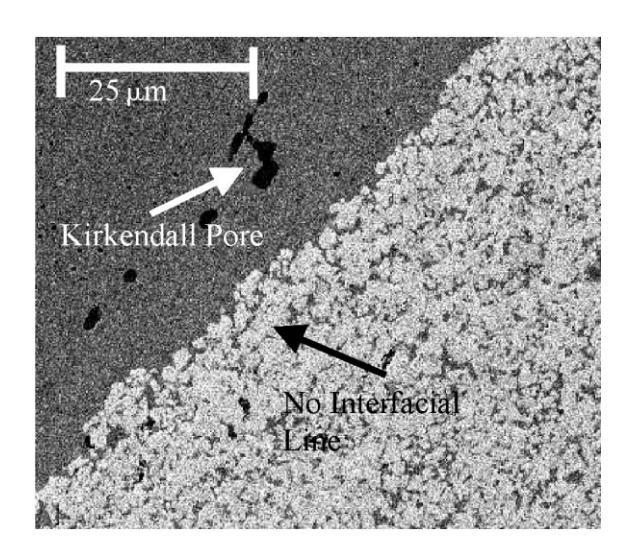
Fig. 19. Coating/substrate interface of T8.
