Wear 230 (1999) 39-55

# Failure modes of plasma sprayed WC-15%Co coated rolling elements

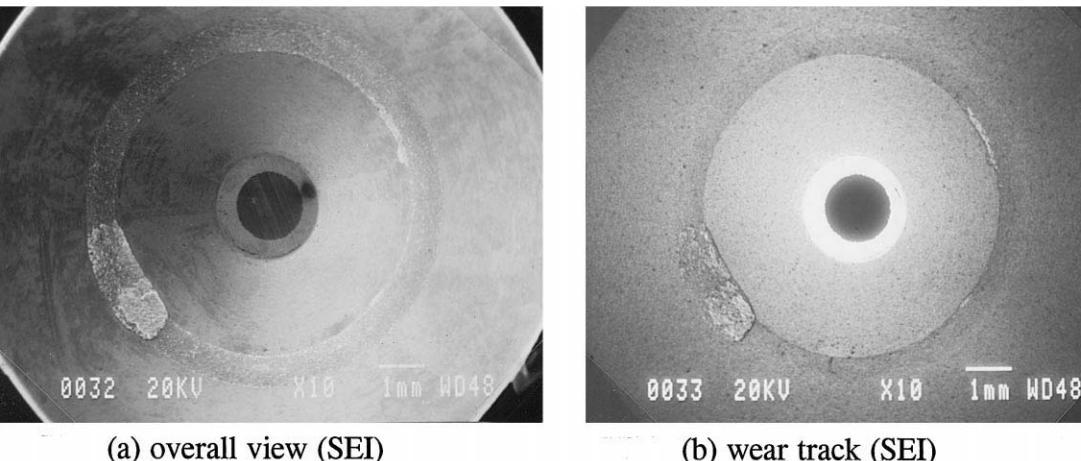
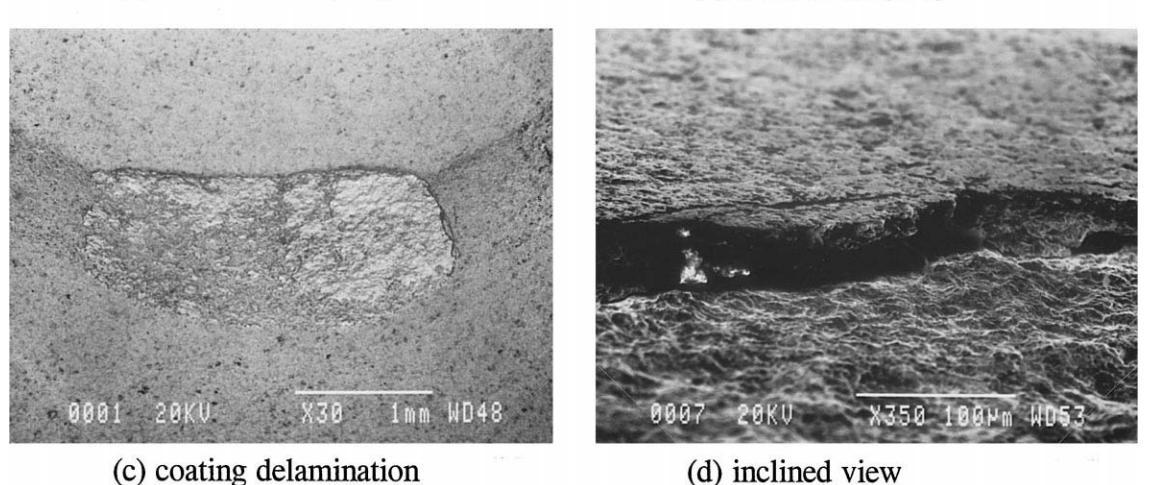
Fig. 2. Surface observations of the rolling element cone GG3AX.

Fig. 2 shows the surface observations of the failed rolling element used to conduct the test GG3AX. In this case the coating delaminated from within the coating microstructure at two locations. Fig. 2(a) shows the overall view of the wear track in SEI (secondary electron image) whereas Fig. 2(b) shows the same observation in BEI (back-scattered electron image). The BEI shows that the coating failure was from within the coating microstructure. Fig. 2(c) shows one of the delaminated areas of the coating at higher magnification. The rolling direction was from the left to the right of this figure and a crack can be seen at the leading edge of the delaminated coating. Fig. 2(d) shows the delaminated area at an inclined angle and the depth of the delamination can be appreciated as  $45 \,\mu$ m.

Figs. 2 and 5 show typical surface observations of this type of failure. In this type of failure, larger chunks of coating delaminated parallel to the surface of the wear track resulting in sheet like debris as shown in Fig. 7(b). In the case of thinner coatings (coating thickness  $< 100 \ \mu m$ ) this type of failure generally took place at the coating substrate interface (Fig. 5) at an approximate depth of maximum shear stress. The coating was defined thin if the coating thickness was such that the maximum shear stress was located at or below the coating substrate interface. However, in thicker coatings (coating thickness > 150  $\mu$ m) the delamination took place from within the coating microstructure (Fig. 2). The coating was defined thick if the coating thickness was such that the maximum shear stress was located within the coating microstructure so that shear stresses did not influence the interfacial stresses. Surface observations indicated that the depth of delamination failures can either be approximated as 45  $\mu$ m or 90  $\mu$ m under the given test conditions. These depths can be related to the depths of orthogonal shear stress or maximum shear stress, respectively (Table 1).

Consider the subsurface observations of the failed coated rolling element cone GG3AX. In this case, the approximate coating thickness was 260 µm which can be classified as thick coating under the given test conditions. Fig. 10 indicates that subsurface cracks were initiated at the depth of maximum shear stress and orthogonal shear stress. The origin of these cracks was attributed to the stress concentrations owing to the micropores, microcracks, secondary phase particles as were seen in the coating microstructure (Fig. 8) which eventually resulted in the macro-pitting of surface. This was consistent with the work described by Littmann and Winder (1966) [16], in which subsurface inclusions and oxides were thought to be the cause of subsurface fatigue due to crack initiation and propagation at the depths of maximum shear stress and orthogonal shear stress. The stress concentrations due to the defects in the coating microstructure were also influential in poor behaviour of these coating during the microhardness/fracture toughness studies (Fig. 11). These studies revealed that coating cracked readily at low indentation loads (100 p) at some locations whereas resisted cracking at even higher loads at other locations. This difference is attributed not only to the variations in density of microstructural defects but also their shape and size. It was appreciated that the indentation load caused stress concentrations at the location of coating microstructural defects. This led to the cracking of the coating microstructure at low indentation loads. This also showed the difficulties in attaining the experimental data on the mechanical properties of these highly anisotropic thermal spray coatings.

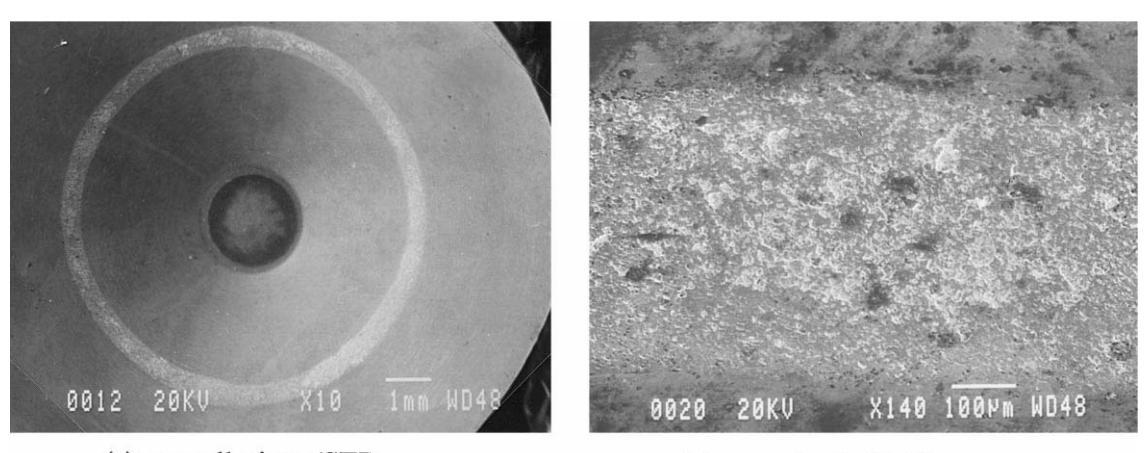
Fig. 3 shows the surface observations of the rolling element subjected to the test conditions as described in the test number GG4AY. Fig. 3(a) shows the overall view of the failed area. The coating failure was due to the forma-

tion of micro-pits on the surface of the wear track as shown at a higher magnification in Fig. 3(b).

this was the only failure mechanism. Figs. 3 and 4 represent some of the cases in which surface wear was mainly responsible for the failure of rolling elements. In this type of failure, numerous micropits appeared on the wear track of coated rolling element. These micropits were similar to the micropits seen on the worn gear and bearing surfaces and resulted from the interaction of surface asperities.

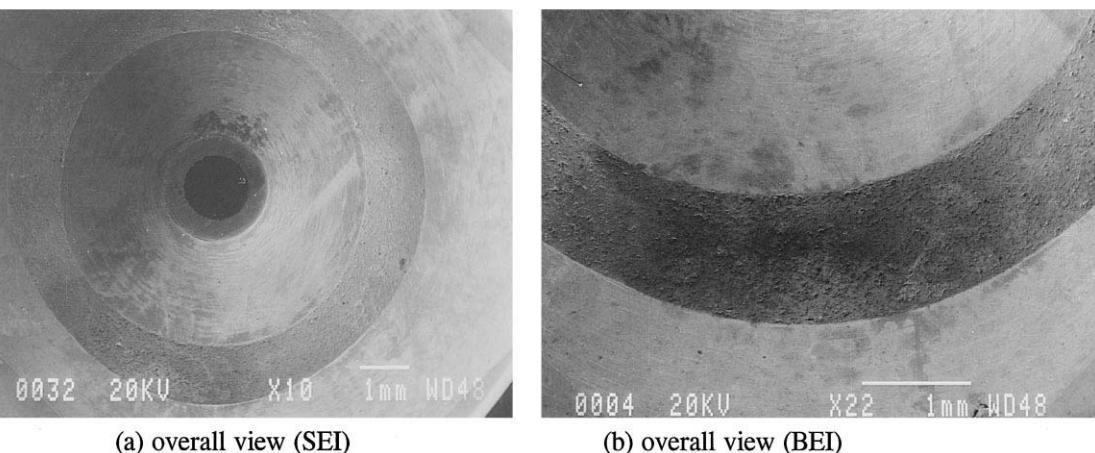
Fig. 4. Surface observations of the rolling element cone GG6AX.

Fig. 4 shows the surface observations for the rolling element subjected to the test GG6AX. Fig. 4(a) shows the overall view of the wear track in SEI whereas, the BEI of the wear track is shown in Fig. 4(b). No delamination was observed in this case and the failure was similar to the surface observations of GG4AY (Fig. 3). This test was conducted to investigate the possibilities of lubricant entrapment mechanisms during the RCF tests.

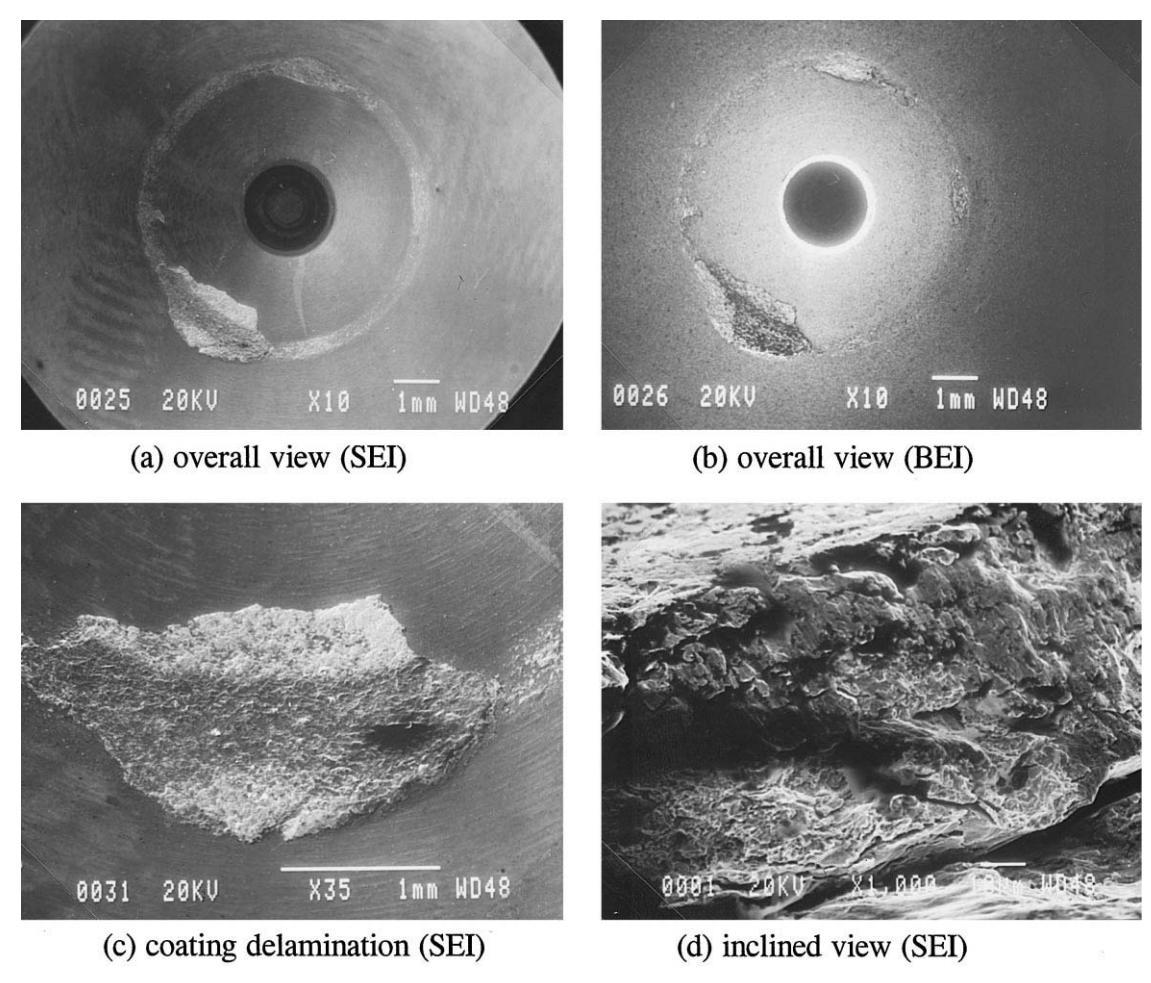
Fig. 5. Surface observations of the rolling element cone GG2BY.

Fig. 5 shows the surface observations of the rolling element cone subjected to the test GG2BY. Fig. 5(a) shows the overall view of the wear track in SEI, whereas Fig. 5(b) shows the same area in BEI. The atomic contrast image in BEI observation confirmed that the coating delaminated at the coating substrate interface at some locations and from within the coating microstructure at other locations. Fig. 5(c) shows the interfacial delaminated coating at higher magnification. Fig. 5(d) shows the inclined angle view of the delaminated coating. The depth of delamination can be approximated as 65 µm.

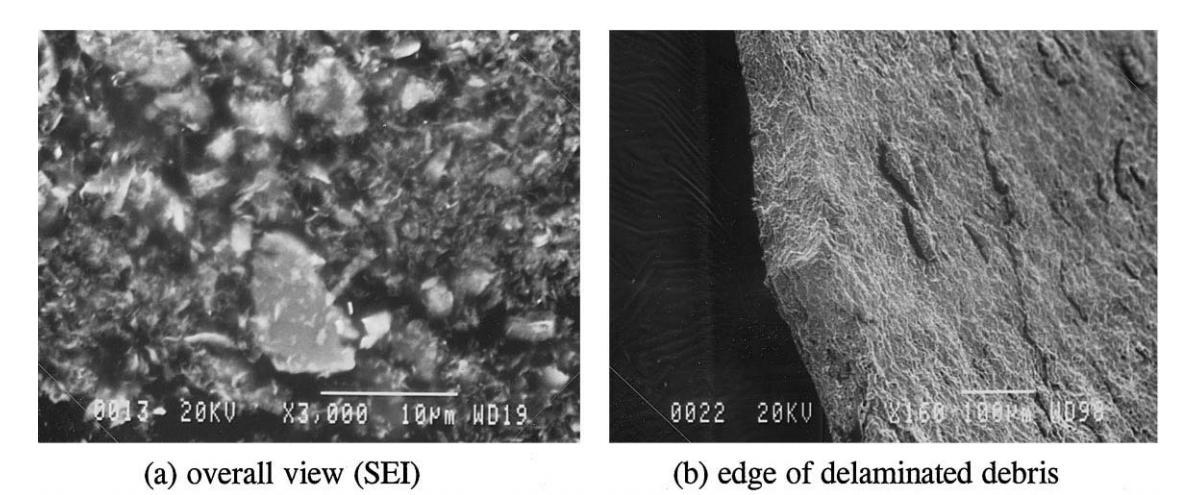
Fig. 6. Surface observations of the debris from the tests GG1AX and GG4AX.

Fig. 6(a) shows the debris collected from the lubricant (Hitec-174) used for the test GG1AX [10]. EPMA analysis of the debris showed a mixture of W, Co and Fe which indicated that the debris were generated from the coated rolling element cone as well as from the lower planetary steel balls. Similar debris were seen for the tests which failed due to surface wear. Fig. 6(b) shows the surface observations of the debris collected from the lubricant (Exxon-2389) used for the test GG4AX [10]. These debris were in the form of thin sheet and few millimetres in length and width. The thickness of debris was approximated as 100 µm (Fig. 6b).

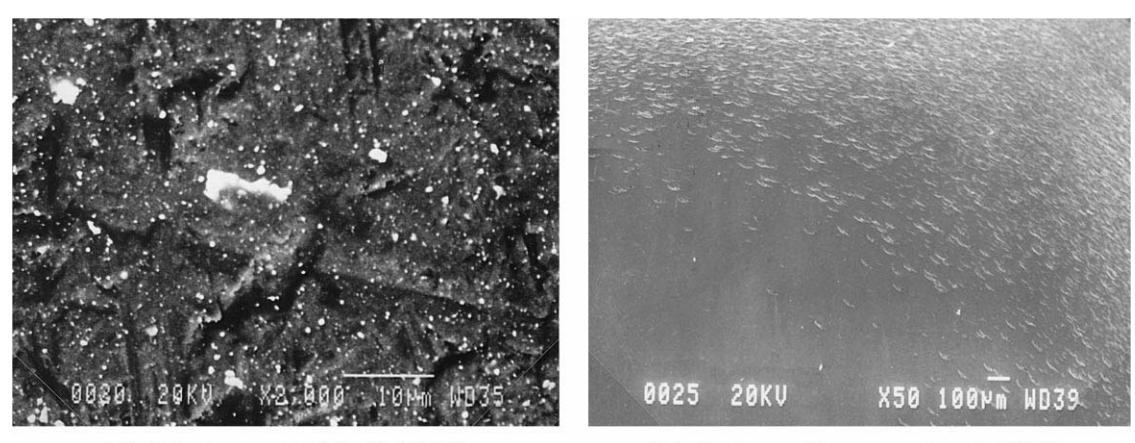
Fig. 7(a) shows debris on the surface of the lower steel ball in BEI (test GG5AX). The size of the debris can be

appreciated in the range of  $5 \times 3 \ \mu m$  to  $1 \times 1 \ \mu m$ . The EPMA analysis confirmed that these debris were W and Co. These debris were seen in abundance on the surface of

the lower steel balls; however, the debris on the surface of the lower ceramic balls were very rare. Abrasion was also seen on the surface of the lower steel balls as shown in

Fig. 7(b) (test GG1AX, [10]); however, this behaviour was not observed on the lower ceramic balls.

Surface observations of lower planetary balls (Fig. 7a) showed that WC debris were adhered (transferred) to the surface of steel planetary balls. Similar trend was observed with other tests conducted with steel lower balls. The size of these adhered debris was generally in the range of 1  $\mu$ m. This indicated that asperity adhesion took place during the RCF tests. These debris were strongly adhered to the surface and did not come off during the ultrasonic cleaning (acetone bath) of lower planetary balls. This trend was however not so definite in the case of planetary ceramic balls. Except in one case, no debris were observed on the surface of lower ceramic balls. This difference was attributed to the differences in the metallurgy and surface chemistry of steel and ceramic balls.

Ploughing and three body abrasion on the lower planetary steel balls can be seen from Fig. 7(b). Abrasion on the wear track of planetary steel balls was attributed to the lower hardness (HV 850) of steel planetary balls in comparison to the hardness of coating (HV 1158). The WC debris produced during the test were approximated to be of the same or higher hardness than the hardness of the coating to further accelerate the process of abrasion. The process was however different in the case of lower ceramic planetary balls. Abrasion of planetary balls was negligible in the case of ceramic lower balls, which was attributed to the higher hardness of ceramic balls (HV 1580). This indicated that ceramic planetary balls outclassed the coatings due to their higher hardness resulting in lower RCF life of tests conducted in hybrid ceramic bearing configuration. Similarly, on the surface of wear track of failed coated rolling elements abrasion was observed as shown in Fig. 3(b)Fig. 4(b).

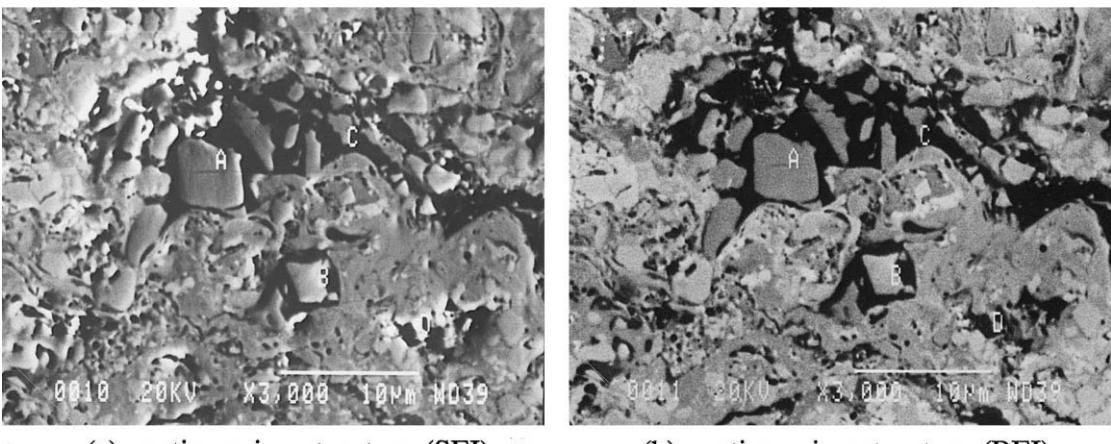
Fig. 8. Coating microstructure.

Fig. 8 shows the coating microstructure revealed after polishing the coating cross section using conventional polishing techniques. Fig. 8(a) shows the coating microstructure in SEI, whereas Fig. 8(b) shows the microstructure in BEI. It can be appreciated that the microstructure contains numerous pores and micro-cracks which can be seen within the WC particles. The existence of these microcracks and micropores was further verified by analysing the coating microstructure at higher magnifications. The atomic contrast images in the BEI indicated that there were secondary phase particles in the coating microstructure. The presence of secondary phase particles was confirmed by the EPMA analysis taken at points A, B, C and D (Fig. 8b). The darker angular particles as shown at point A indicated a strong peak of W and Co. At location B which was a much brighter phase resulted in a strong W peak only. This showed that at location A, some of WC reacted with Co during the plasma spraying process. This behaviour was consistent with the studies by Harvey et. al. (1995) [12]. They reported the formation of an amorphous W-Co-C phase due to the melting of WC-Co particles. At location B, however, it appeared that plain WC was present, which was indicative of either retained WC in the coating microstructure or the presence of W<sub>2</sub>C particles. The EPMA analysis at location C indicated a strong Co peak indicating the Cobalt matrix. At location D, there were weak peaks of W, Co, etc., with a high background noise in the signal which was typical of porosity within the coating microstructure. The existence of various phases within the coating microstructure was further verified using X-ray diffraction analysis. The size

of angular WC or W2C particles was approximated to be in the range of  $2 \times 2 \ \mu m$  to  $10 \times 5 \ \mu m$ . These observations indicated that the coating microstructure contained a mixture of defects such as micro-pores, micro-cracks and secondary phase particles, etc. These defects were seen not only at the interaction of lamellas within the coating but also at the coating substrate interface. No attempt was made to quantify the level of porosity in the microstructure.

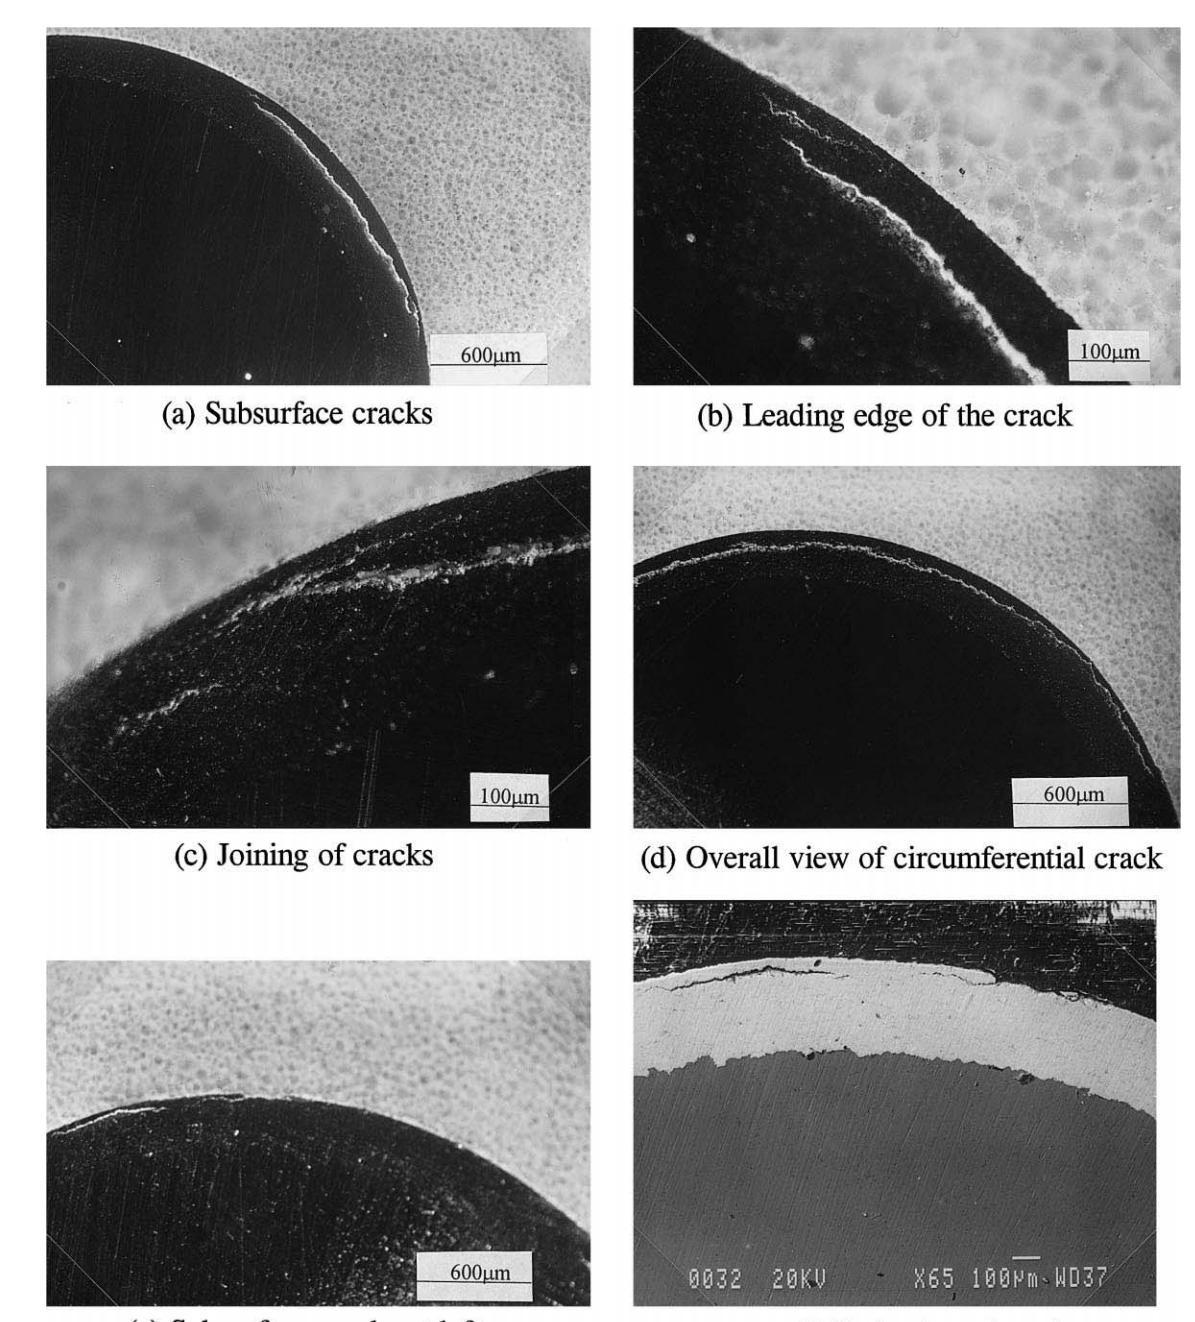
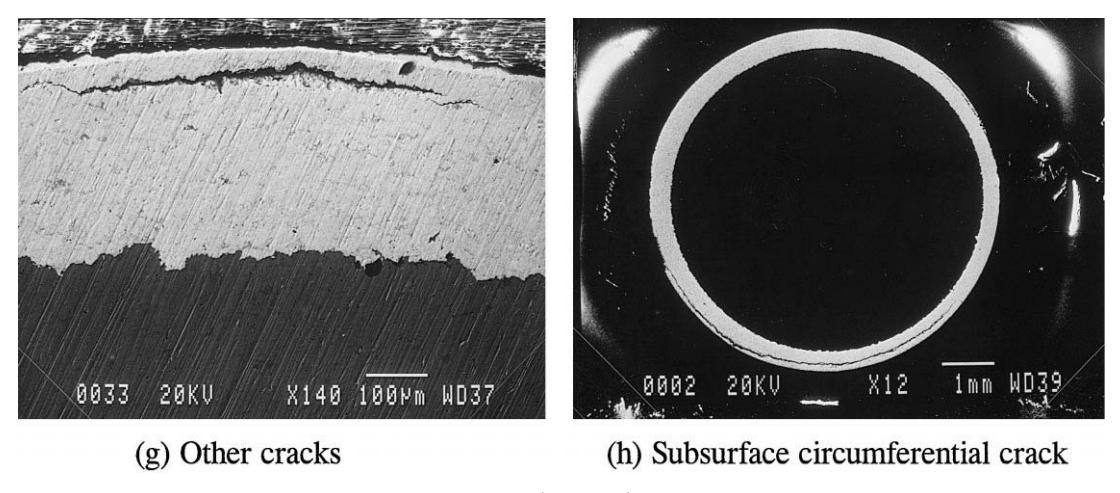
Fig. 9. Subsurface observations (GG3AX).

Fig. 9 shows the subsurface observations of the rolling element cone used for the test GG3AX. The surface observations of this rolling element (Fig. 2) indicated that the rolling element delaminated from within the coating microstructure. Fig. 9(a) shows subsurface cracks observed

under the ultraviolet light just before the edge of wear track. Three different cracks were visible at two different depths under the surface of the wear track. The big crack in the middle can be seen at a deeper depth while two hairline cracks can be seen appearing on either end of the big crack at a shallower depth. Considering the magnification of the image and taking account of the apex angle, the coating thickness was approximated as 260  $\mu$ m. Similarly, the maximum depth of the big crack and the short shallow cracks on either ends for the contact was approximated as 90  $\mu$ m and 45  $\mu$ m, respectively. The rolling direction was from the right to the left of the figure. Fig. 9(b) shows the leading edge of the big crack at a higher magnification. Two independent cracks at two different depths can be seen clearly at this magnification.

Fig. 9(c) shows subsurface observations after some more grinding along the axis of the rolling element cone into the wear track. The cracks extended in length in both directions and joined together. Another short and independent subsurface crack also appeared on the left of the big crack at a contact depth of approximately 90  $\mu$ m. As the progressive grinding through the wear track continued the big crack extended in length in both directions either independently or by joining other cracks as shown in Fig. 9(d). Apart from the propagation of this big crack, new independent cracks appeared under the surface of wear track as shown in Fig. 9(e). This crack emerged on the left of big crack which is visible on the right of figure. It was found that this crack lead to the delamination of rolling element from within the coating microstructure. These fluorescent dye investigations confirmed that these cracks were generated during the RCF and not due to the sectioning process, SEM observations were made on these cracks for analysis at higher magnifications. Fig. 9(f) shows the crack associated with the delaminated section of the coating. The depth of failure can be approximated as 45  $\mu$ m. New cracks were also visible at this depth as shown at a higher magnification in Fig. 9(g). These cracks ultimately joined together with the big crack during the RCF test to form a long circumferential crack as shown in Fig. 9(h).

Once these cracks were initiated they propagated at the specific depths of shear stresses. It was observed that the behaviour of crack propagation at two different depths of shear stresses was different. The cracks at the depth of maximum shear stress continued to develop in both directions either by the propagation of single crack or by the combination of small cracks at the same depth (Fig. 9b). When the location of these cracks became such that they occurred in the vicinity of another crack (at orthogonal shear stress), the cracks (at maximum shear stress) approached the crack at the depth of orthogonal shear stress. This was accompanied by a change in the direction of crack propagation towards the surface (Fig. 9c). In general, the cracks at the depth of maximum shear stress did not directly reach the surface. After the combination of the two cracks which initiated at two different depths, the combined crack generally propagated at the depth of orthogonal shear stress.

The independent cracks at the depth of orthogonal shear stress (Fig. 9e and g) propagated in the same manner as the cracks at maximum shear stress, i.e., parallel to the surface. However, these cracks were generally shorter in length and eventually reached the surface after reaching a certain crack length. This resulted in delaminating the coating at the depth of orthogonal shear stress (approximately 45  $\mu$ m) for thick coatings (Fig. 9f).

(a) The delaminated coating and subsurface cracks extended much beyond the width of the wear track as seen in Fig. 9(a). This cannot be explained by the mechanism of hydrostatic pressure build-up as the stresses will be tensile at the edge of the wear track. (b) Cracks occurred subsurface and only at specific depths and travelled circumferentially parallel to the surface.

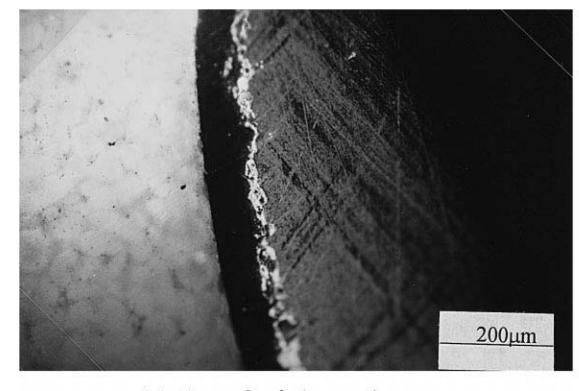
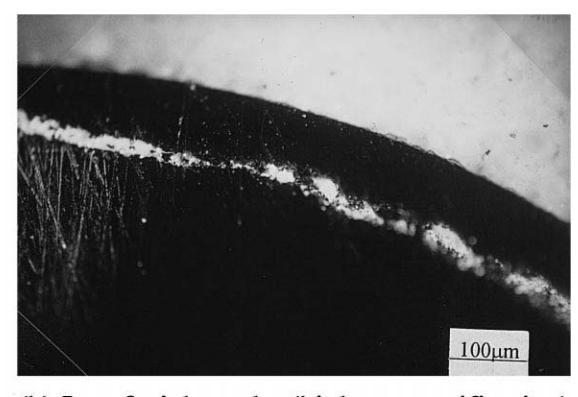
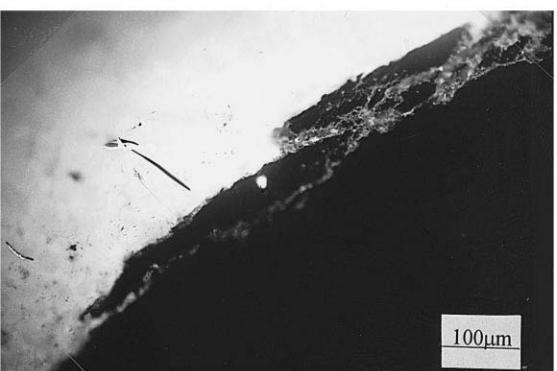
Fig. 10 shows the subsurface observations of the coated rolling element cone used for the test GG2BY. The rolling element failed because of the coating delamination at the interface (Fig. 5). Subsurface interfacial (coating/substrate interface) cracks were observed at the edge of the wear track. Fig. 10(a) shows a view of these cracks under ultraviolet light whereas, Fig. 10(b) shows these cracks at another location at a higher magnification. Using basic trigonometric relations the contact depth of these interfacial cracks was approximated as 70  $\mu$ m. As more grinding was carried out along the axis of the cone, these subsurface cracks reached the surface exposing the delaminated area

(c) Delaminated section (d) Interfacial crack propagation s Fig. 10. Subsurface observations (GG2BY). of the coating. Fig. 10(c) shows these subsurface cracks under the delaminated section of the coating. The coating delamination can be observed at two different depths under the surface of the wear track, i.e., (i) at the coating substrate interface as seen on the left of the figure and (ii) from within the coating microstructure at a contact depth which was approximated as 30 µm. The rolling direction was from the right to the left of the figure. It can be appreciated that if these cracks were thought to initiate and propagate from the surface towards the interface of the coating, they must have propagated in the direction opposite to rolling. However, if the cracks initiated and propagated from subsurface to surface then the direction of propagation was in the direction of rolling at the leading edge of the contact and visa versa at the trailing edge of the contact. Fig. 10(d) shows few other interfacial cracks which reached the surface.

The mechanism of crack propagation in thin coatings was different to thick coatings. Consider the subsurface observations of the rolling element cone GG2BY (Fig. 10).

In this case, the coating thickness was approximately 80 μm. The coating can thus be regarded as thin coating, i.e., maximum shear stress was located near the coating substrate interface. The initiation and propagation of these cracks was attributed to the same factors as described above with the additional effects of stress concentrations caused by the mismatch of coating and substrate properties at the interface. This effect of mismatch of the mechanical properties (Young's modulus, Poisons ratio) and the possibility of the presence of inclusions, contamination layers at the interface provided an acceleration in the crack initiation and propagation at the interface. Therefore, in the case of thinner coatings the cracks at the depth of maximum shear stress (located at the interface) initiated and propagated much quicker than the cracks at the orthogonal shear stress. These cracks reach the surface either independently leading to coating delamination at the interface or after joining with cracks at orthogonal shear stress. Fig. 10(c) shows a view in which both types of delamination are visible. However, in most of the cases of thinner coatings interfacial cracking and interfacial delamination were common. The poor performance of thinner coatings can thus be understood by the accelerated crack propagation at the coating substrate interface.

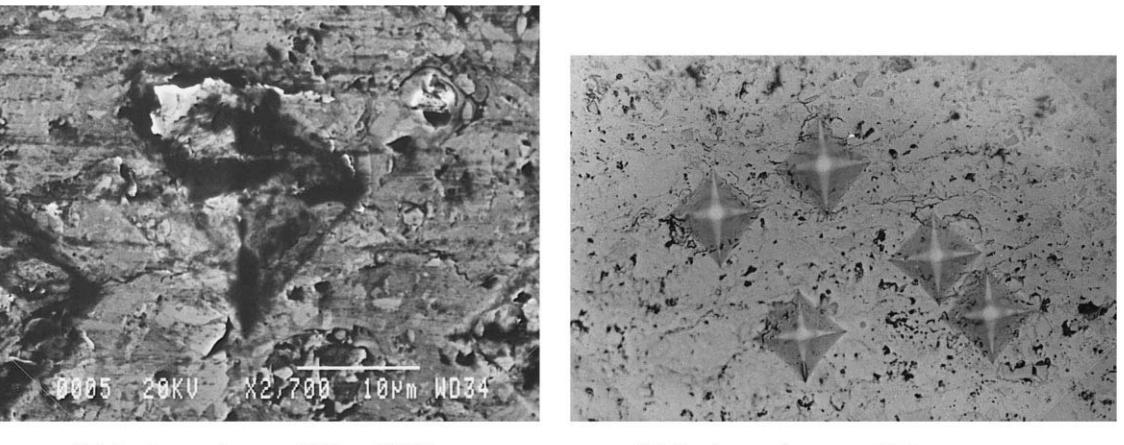
(a) Indentation at 300p (SEI) (b) Indentations at 500p Fig. 11. Micro-hardness indentations.

Attempts were also made to study the indentation fracture toughness ( $K_{1c}$ ) and the critical strain energy release rate ( $G_c$ ) of thermal spray coatings using the diamond indentation technique. However, even after repeated attempts and extreme care in preparing the surface for microhardness indentations, it was not possible to obtain a reliable value of  $K_{1c}$  or  $G_c$ . It was mainly because the coating cracked at some locations at an indentation load of 100 p and at other locations at load of 300 p or 500 p. Fig. 11(a) shows a typical result in which the coating cracked at an indentation load of 300 p. Moreover, the cracks did not satisfy the criteria (C > 2b, where C is the crack length and b is the diagonal of indentation). The cracks did not always originate from the notch of the diamond indentation but also from the sides of indentation. This indicated that the stress concentrations at the pores and micro-cracks within the coating microstructure were higher than the theoretically applied load, which caused these cracks to originate and propagate during the indentation process. Some of these observations are shown in Fig. 11(b).
