The effects of material combination and surface roughness in lubricated silicon nitride/steel rolling contact fatigue

J. Kang^{a,*}, M. Hadfield^a, R. Ahmed^b

Abstract

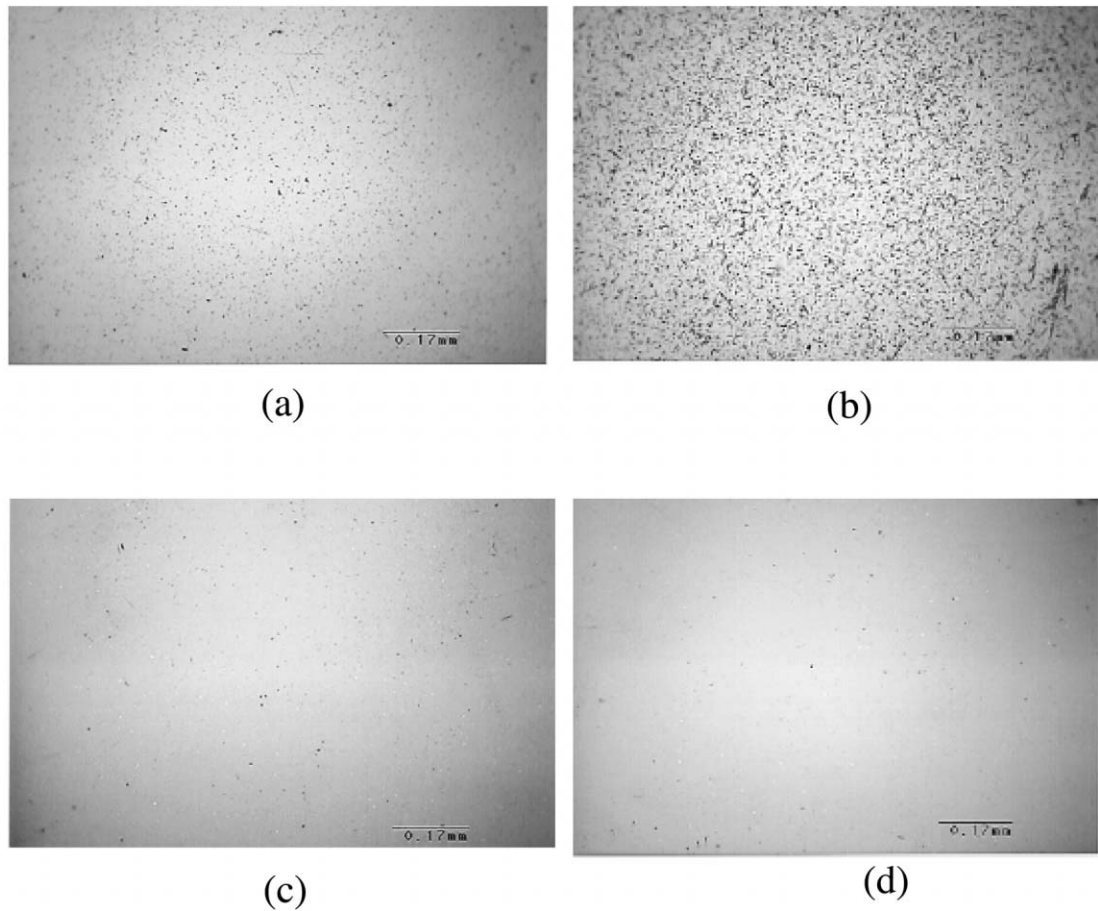
Fig. 2. Photomicrographs of the HIPed Si_3N_4 surfaces of samples A to D before testing.

Four kinds of HIPed silicon nitride balls with diameters 12.7 mm (0.5 inch), commercially finished to grade 5, were procured from different manufacturers, and were designated as A, B, C and D. Table 1 summarises the measured geometric and material properties of testing samples A–D. Surface hardness were measured using a Buehler Hardness Indenter, at a load 10 kg, loading time 10 s and loading speed 100 $\mu\text{m}/\text{s}$. Fig. 1 gives the detailed statistical analysis values for different roughness parameters of testing samples A through D measured by a Talysurf 2D surface profiler, with each sample 3 balls, each ball 3 points. Fig. 2 is the microscopy observation on the surfaces of samples A~D before RCF test.

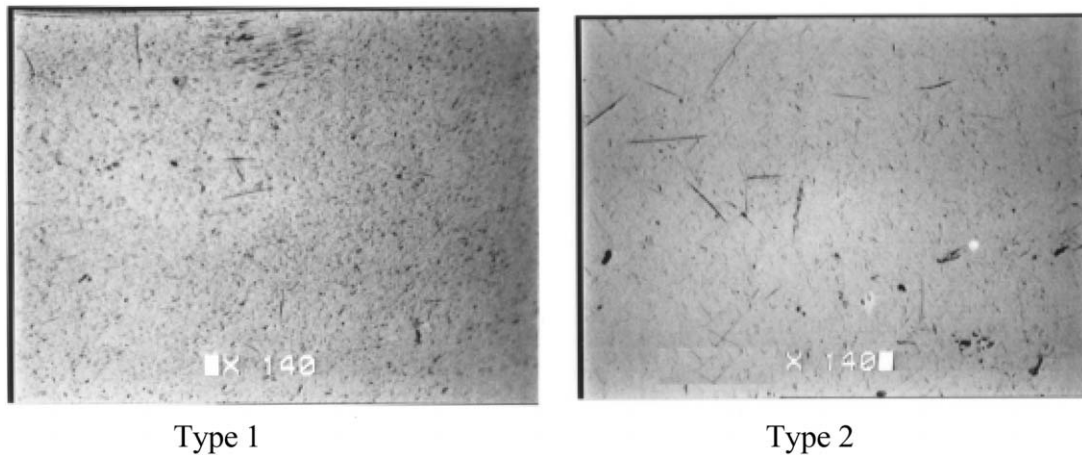
Fig. 3. Photomicrographs of the surfaces of two kinds of steel testing balls

In this study, the steel test samples were procured from two different suppliers. They were both supplied as standard steel testing balls (specification: 0.5 inch ball Reference RB12.7/310995A, material: AISI 52100 bearing steel). The measured geometric and physical properties of the steel testing balls are listed in Table 2. Fig. 3 shows the surface microscopy images of the two kinds of steel balls.

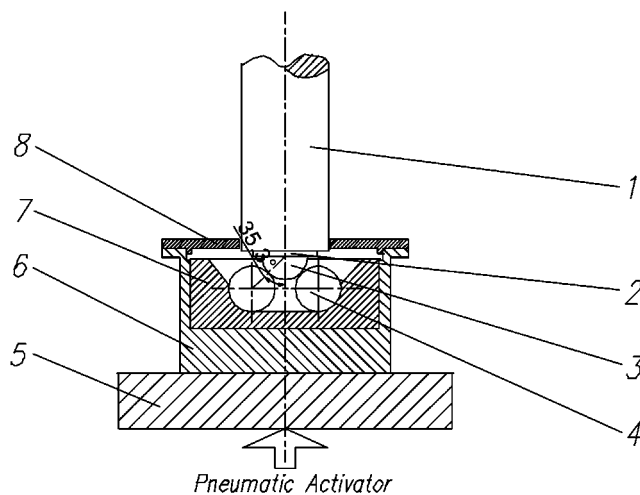
Fig. 4. Schematic of the modified four-ball rolling configuration

Accelerated rolling contact fatigue tests were performed on a Plint TE92 HS 10 000 rev./min Microprocessor Controlled Rotary Tribometer [10]. In this study, it was configured as a high-speed modified four-ball machine according to the Institute of Petroleum (UK) IP 300 rolling test procedure. Fig. 4 is the schematic of the modified four-ball rolling configuration. The upper ball (3) is held in the collet (2) and rotates at the

spindle (1) speed. The retainer cup (7) has a race with slightly bigger radius than 0.5 inch ball to accommodate three lower balls (4). Oil can be filled full of cup before test, and during testing period oil can be added through a hole in the cup cover (8) to maintain the test in fully lubricated condition. The heater pad (5) in conjunction with a thermocouple ensures that the temperature is above the specified value. When temperature is lower than this specified value, the heater pad will be on. The four-ball rolling kinematics was described by Kruger and Bartz in chapter 10 of reference [11], the current configuration was categorised as type II machine. The upper ball stress cycle factor L is:

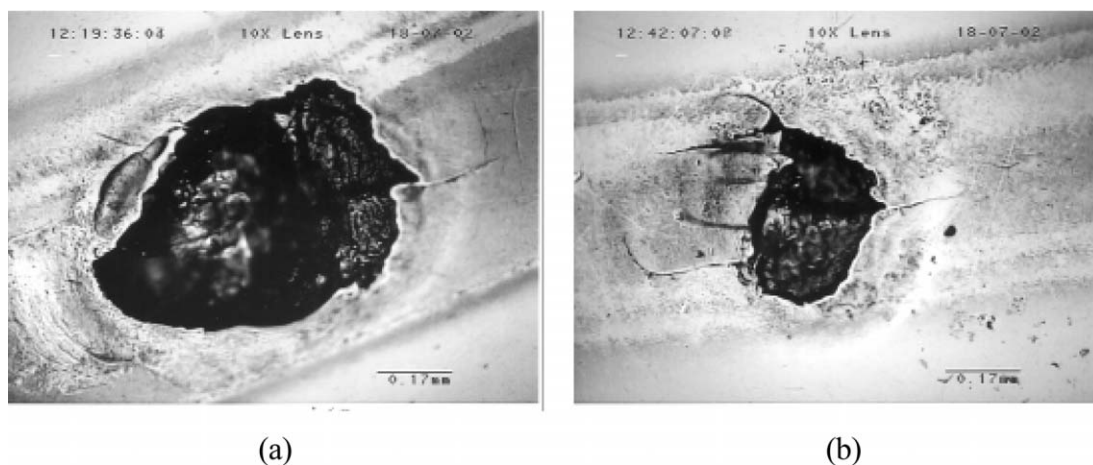
Fig. 5. Typical big and small fatigue spalls on steel balls.

failure of the lower steel ball is normally a fatigue spall on the rolling track as shown in Fig. 5. By changing the lower steel balls, the rolling contact stress cycles for the upper silicon nitride ball is assured. After each test, the upper silicon nitride ball was cleaned in an ultrasonic bath by acetone. Microscopy, Scanning Electron Microscope (SEM), interference profilometry and 3D topographic analysis were conducted.

various sizes, as shown in Fig. 5. These fatigue spalls were comparable in size with the rolling track width (diameter of the Hertzian contact circle). The fatigue spall in Fig. 5a is approximately $700 \times 500 \mu\text{m}$, whilst in Fig. 5b it is approximately $380 \times 250 \mu\text{m}$. When one of the steel balls failed with a fatigue spall, three new steel balls of the same type were fitted, and the time for this kind of change is listed in Table 3 under the column of 'Lower balls changed after (hours)'. Fig. 6 shows the microscopy observations of the rolling tracks of silicon nitride A–D after testing.

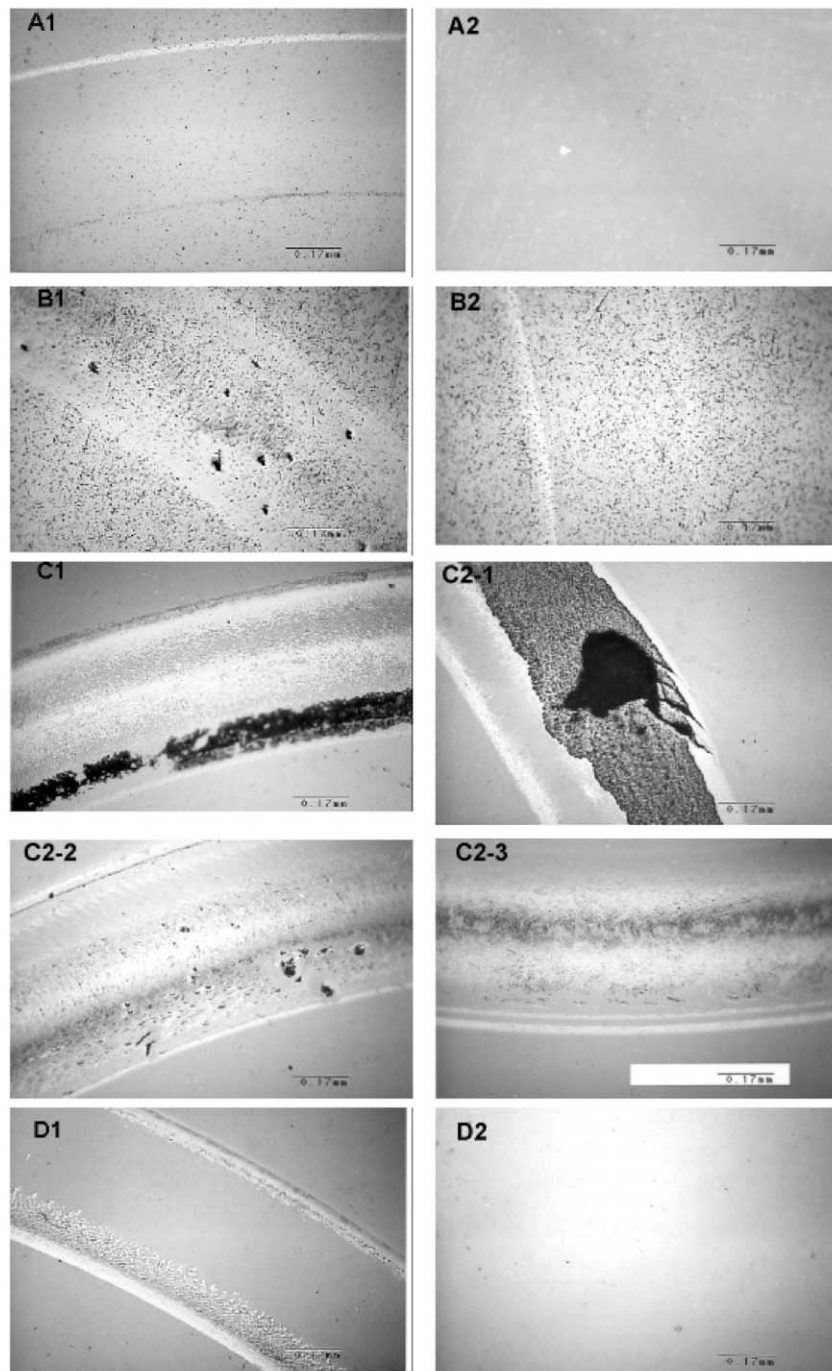
Fig. 6. Photomicrographs of the rolling tracks of samples A to D after testing.

has more valleys than peaks). After 134.35 h RCF test (181 million stress cycles) with Type 1 steel balls, no difference can be observed on the rolling track under optical microscope (Fig. 6 A1) except for the oil stain deposited on the outer edge of the rolling track which could not be removed by ultrasonic cleaning. Fig. 7 is the analysis of the rolling track by the 3D surface analyser. From the Oblique Plot of Fig. 7, slight wear on the rolling track can be seen. The amount of wear is identified by the Surface Profile (the section view of Oblique Plot) in the range of 0.05~0.1 μm .

After silicon nitride A in rolling contact with Type 2 steel balls for 125.59 h (169.5 million stress cycles), the rolling track can hardly be seen under microscope with bright field. Fig. 6 A2 is the rolling track under microscope with dark field. The rolling track can only be recognised by contrast in colour. No oil deposit can be found at the edges of the rolling track.

wear can be observed on the rolling track under microscope, only oil deposited at the rolling track edges, as shown in Fig. 6B2. In order to verify this, a 3D topography analysis was conducted on the rolling track. Fig. 9 is the analysis result, and wear cannot be seen in the 3D Oblique Plot. From the Surface Profile of Fig. 9, the height of the oil residuals at the right edge of the rolling track is about $0.2 \mu\text{m}$.

Silicon nitride C are with an average R_a value $0.002 \mu\text{m}$. After 110.48 h RCF test (149 million stress cycles) with Type 1 steel balls, the rolling track surface of C1 became rougher under optical microscopy observation (Fig. 6 C1). Oil residuals have deposited on both rolling

For silicon nitride C with Type 2 steel balls, three tests were conducted. Sample C2-1 failed with a fatigue spall after 21.94 h (29.6 million stress cycles) as shown in Fig. 6 C2-1. This spall was examined by the 3D

test, wear can be observed on the rolling track under microscope, and some small pittings in the dimension of 20–40 μm also appeared on the rolling track (Fig. 6 C2-2). Fig. 14 shows the interference profilometry image of the outer edge of the rolling track. A narrow oil deposit zone is near the edge of the rolling track, and immediate outside the oil deposit zone is a deep groove. Wear can also be seen inside the rolling track.

rolling track can hardly be recognised under microscopy, as shown in Fig. 6 D2.

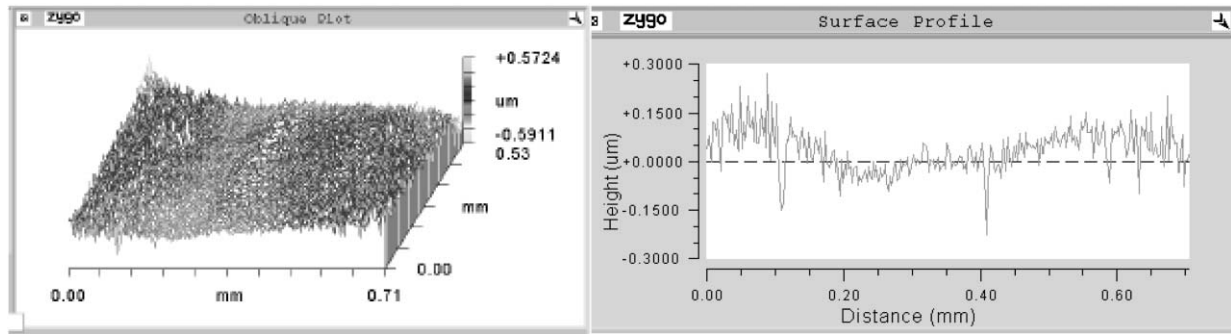
Fig. 7. Rolling wear track of sample A1 observed by 3D surface structure analysis.

kurtosis value R_{ku} of 34.7, and also disclosed by a high average R_p (the maximum height of the profile above the mean line) value of 0.030 mm and a low average R_v value of 0.009 μm . After RCF tests, no difference can be observed on the rolling tracks under microscope (Fig. 6 A1, A2, D1, D2). The wear on the rolling tracks were very small as measured by an analytical balance, in the range of 0.1–1 mg. If this is converted to volume loss, it would be in the range of $0.3 \sim 3 \times 10^{-10} \text{ m}^3$. The amount of wear examined by 3D surface analysis (Fig. 7) and SEM (Fig. 17) were also very small.

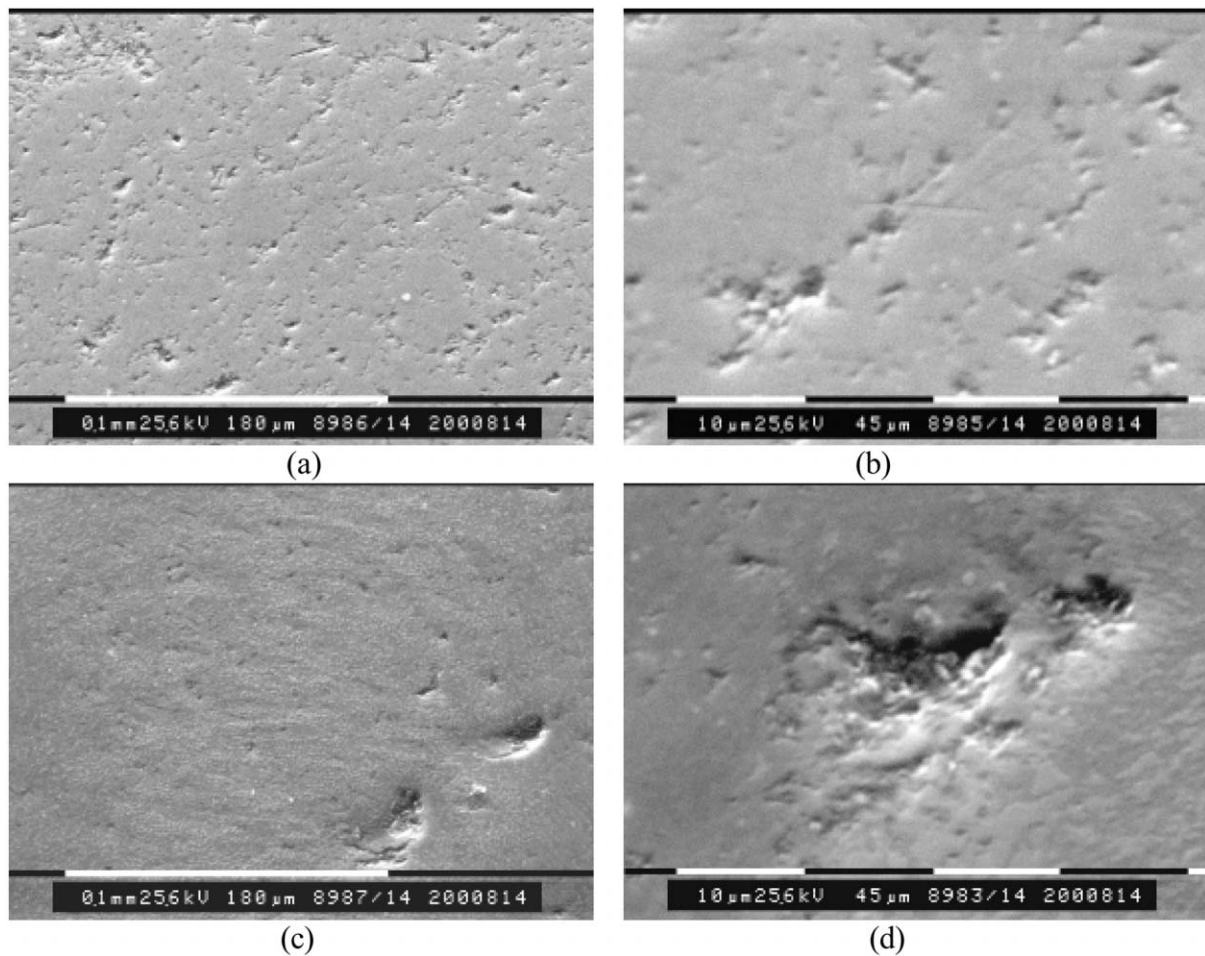
Fig. 8. SEM micrographs of sample B1, (a) and (b) outside the rolling track, (c) and (d) inside the rolling track.

μm and a Δ_q value (root mean square value of average slope) 0.4° . After 100.72 h RCF test (135 million stress cycles) with Type 1 steel balls, under optical microscopy observation (Fig. 6 B1) the surface pitting appears on the rolling track and the sides of the rolling track have become smoother. To verify this, a Scanning Electron Microscopy (SEM) investigation was carried out. Fig. 8 shows the SEM micrographs of sample B1, (a) and (b) outside the rolling track, (c) and (d) inside the rolling track. The SEM investigation leads to an assumption that during the rolling contact test, the vast majority of the small and shallow pits disappeared due to the ‘polishing’ wear process and the surface became smoother. However, some of the larger and deeper pits developed into surface pitting due to microcracking.

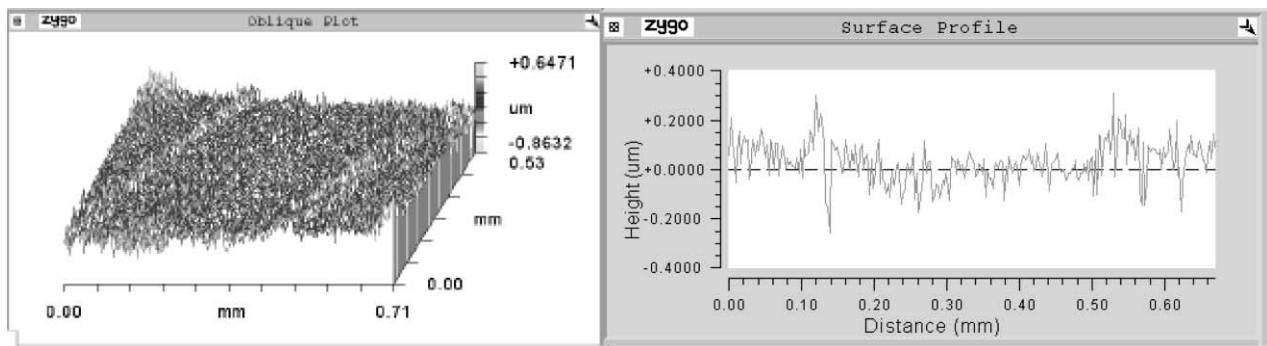
Fig. 10. Rolling track of sample C1 examined by the 3D surface analyzer.

track edges, with some black oil residuals on the inner edge in the width of 0.1 mm. Fig. 10 shows the rolling track of sample C1 examined by the 3-D surface analyser. The amount of wear and the height of the oil deposits are similar to sample A1. A further 3-D surface analysis on the black area of the rolling track confirms

For silicon nitride C in rolling contact with Type 1 steel, the amount of wear on the rolling track is comparable to Sample A1 as measured by 3-D surface analyser (Fig. 10). The rolling track is not as clean as other samples (Fig. 6 C1), and black oil stain deposited on the rolling track (Fig. 11). For silicon nitride C in rolling contact with Type 2 steel, C2-1 failed with a fatigue spall after 29.6 million stress cycles. This failure may be probabilistic, or due to an undetected pre-existed surface defect (flaw) on the rolling track. Two more RCF tests on silicon nitride C in rolling contact with Type 2 steel were conducted, and no further fatigue spall was found. To conduct a reasonable probabilistic failure analysis, at least 20 tests were needed for each kind of samples, and this is beyond the scope and capability of current study. But the further two RCF tests on C2 did show some differences on the rolling tracks, compared with similar surface roughness samples A2 and D2, and compared with the same surface but in rolling contact with Type 1 steel (C1). For Sample C2-2 after 173 million stress cycles, wear and surface pittings can be seen on the rolling track (Fig. 6 C2-2), and interference profilometry image revealed a groove at the edge of the rolling track (Fig. 14). For Sample C2-3 after 60 million stress cycles, wear on the rolling track is severe than samples A1 and C1, as measured by 3D surface analyser (Fig. 15).

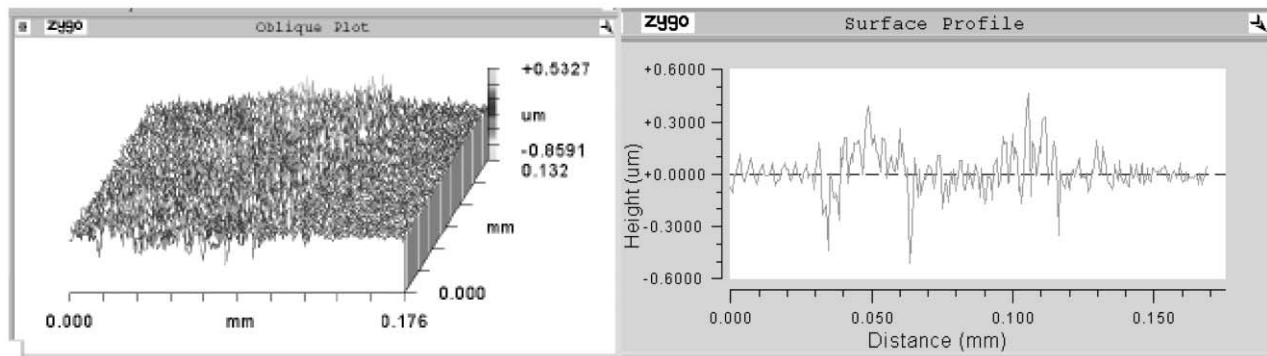
Fig. 11. The black area of sample C1 examined by the 3D surface analyser.

the black thing is oil stain with a height of 0.2~0.3 μm (Fig. 11).

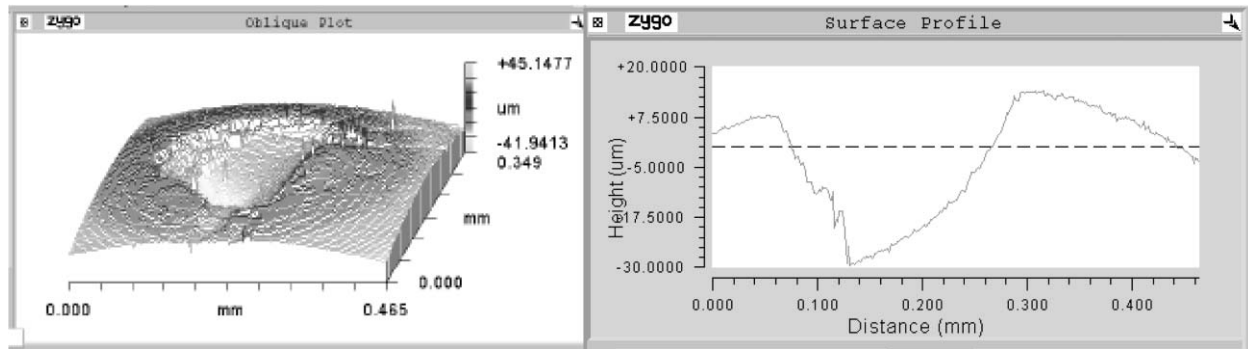
Fig. 12. Rolling track of sample C2-1 observed by 3D surface analysis.

surface analyser, and the result is shown in Fig. 12. The diameter of the spall is approximately 200 μm , and the deepest inside the spall is approximately 40 μm . Delamination occurred adjacent to the spall along the rolling track, a 3D surface analysis shows the depth of the delamination is about 0.8–1 μm (Fig. 13).

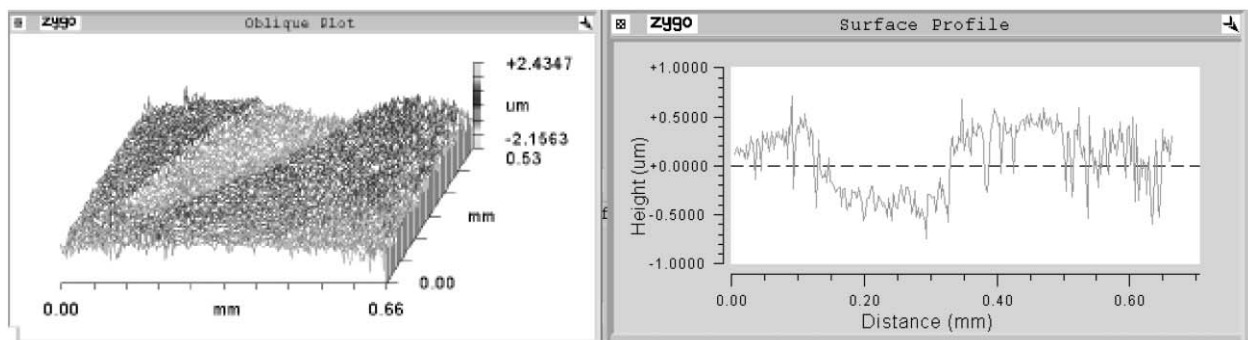
Fig. 13. Delamination on the rolling track of sample C2-1 measured by 3D analysis.

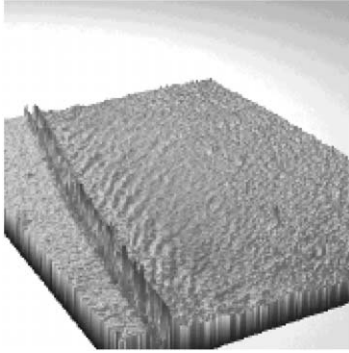
Fig. 14. The interference profilometry image of the rolling track of sample C2-2.

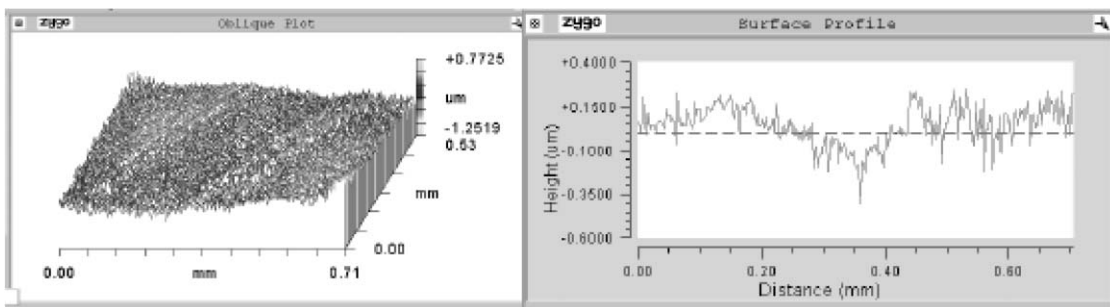
Fig. 15. Rolling track of sample C2-3 observed by 3D surface structure analysis.

track under microscope. The wear is located near the centre of the rolling track, in the range of $0.15 \sim 0.2 \mu\text{m}$ as measured by 3-D surface analysis (Fig. 15), which is severe than samples A1 and C1.

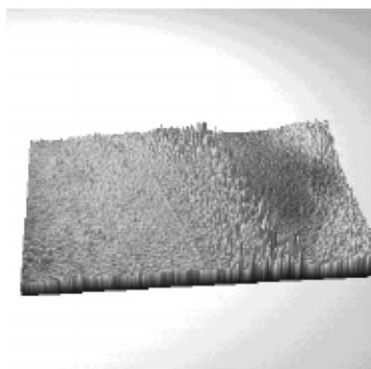
Fig. 16. The interference profilometry image of the rolling track of sample D1.

Silicon nitride D are with an average R_a value $0.002 \mu\text{m}$ and an average R_q value $0.003 \mu\text{m}$, which are the same as samples C. But silicon nitride D are with a high positive skewness value R_{sk} of 3.1 and a very high kurtosis value R_{ku} of 34.7, which means that the surfaces of D have more peaks than valleys and are 'spiky'. After 131.85 h (177 million stress cycles), no difference can be observed on the rolling track of sample D1 except for oil stains at the track edges under optical microscopy (Fig. 6 D1). The high skewness and kurtosis values did not make any difference. The interference profilometry image in Fig. 16 shows the oil stain at the outer edge of the track. Small and shallow pitting around $2 \mu\text{m}$ in size was observed on the rolling track of sample D1 with the SEM as shown in Fig. 17.

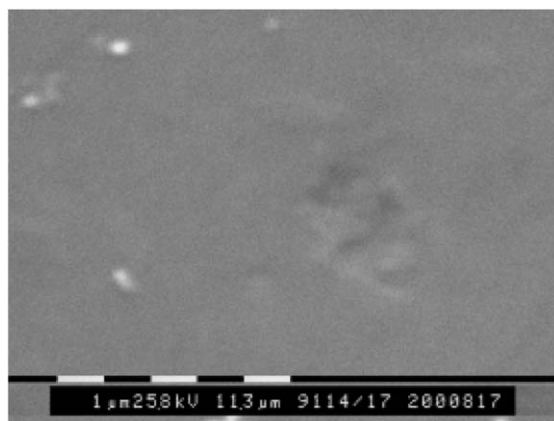
Fig. 17. Small pitting on the rolling track of sample D1 observed by SEM.
