Rolling Contact Fatigue of Hot Isostatic Pressed WC-NiCrBSi Thermal Spray Coatings

S.Stewart, R.Ahmed

Heriot Watt University, Edinburgh, Scotland, UK

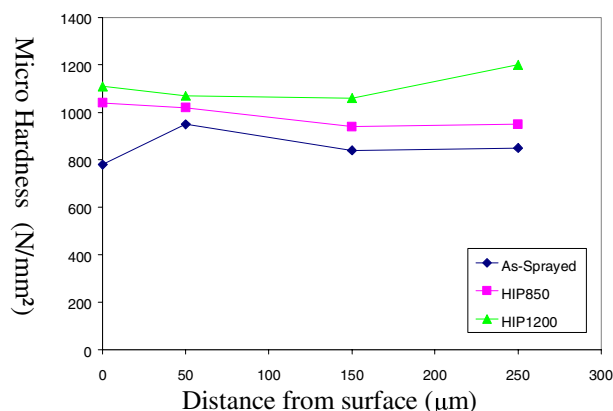
Microhardness and Elastic Modulus measurements were taken on the surface and cross section of As-Sprayed, HIPed at 1123K and HIPed at 1473K coated discs. Hardness measurements were taken on the coating surface at a test load of 500 mN and on the cross section of the coatings at 500 mN. Results are displayed in Figure 10. Results from the As-Sprayed coating show a surface hardness of 780 N/mm². In comparison results from the surface of the coating HIPed at 1123K display an increased hardness of 1040 N/mm². Increasing the HIPing temperature to 1473K lead to an increased surface coating hardness of 1110 N/mm².

Figure 10: Hardness Results for As Sprayed, HIPed at 1123K and HIPed at 1473K Coatings.

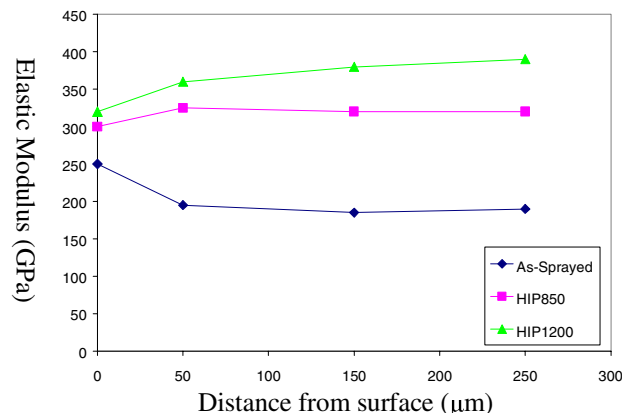
Elastic Modulus results are shown in Figure 11. Results from the surface of the As-Sprayed coating displayed an average value of 250 GPa. Results from the surface of the coating HIPed at 1123K displayed a slightly higher value of 300 GPa. On increasing the HIPing temperature to 1473K , a slight increase in the elastic modulus was observed from surface measurements. Cross sectional analysis of the coatings displayed an increase in elastic modulus away from the

Figure 11: Elastic Modulus Results for As Sprayed, HIPed at 1123K and HIPed at 1473K Coatings.
