Wear 230 (1999) 39-55

# Failure modes of plasma sprayed WC-15%Co coated rolling elements

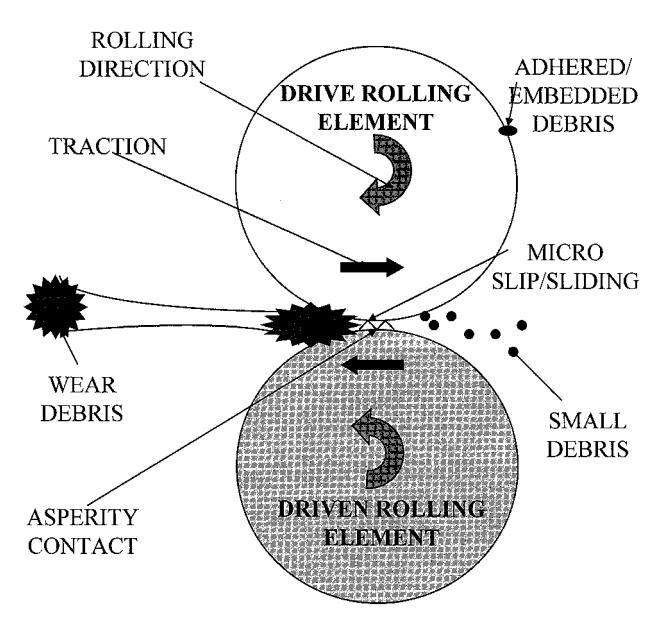
Fig. 12. Schematic of coating surface wear process.

Fig. 12 shows a schematic of surface wear type of coating failure. The figure shows the initiation of wear debris at the asperity contact due to the above discussed mechanism and further acceleration of process due to action of wear debris. The behaviour of wear debris entering the contact area of rolling sliding contact is, however, complex depending upon the size, shape, composition, hardness, of debris and the tribological conditions within the contact region. No attempts were made to investigate the effect of shape and size of wear debris on the rate of surface wear process. Sayles (1995) [15] has given some description of influence of these factors.

contact. Thus surface wear should not be observed with this lubricant. However, surface observations indicated surface wear for the tests conducted with Hitec-174 lubricant. This difference between the lubrication regime and surface wear was attributed to the following reasons: (a) At the start of RCF tests the EHL film is not fully developed providing a possibility of asperity contact within the contact region. Also, the effect of running in period cannot be overlooked. (b) During the RCF tests theoretical film calculations indicate a value of  $\lambda$  in the range of 3 to 4. This marks the beginning of fully developed lubrication film. Slight changes in surface roughness and lubricant viscosity (due to flash temperature, friction) can cause this regime to migrate into the mixed region. These calculations were based upon the average root mean square  $(R_{q})$ values of surface roughness. Some asperity peaks will always be higher then the average asperity height, which can provide an initial asperity contact leading to the generation of wear debris. Moreover, two-dimensional surface roughness parameters were used in the calculations of  $\lambda$ value.

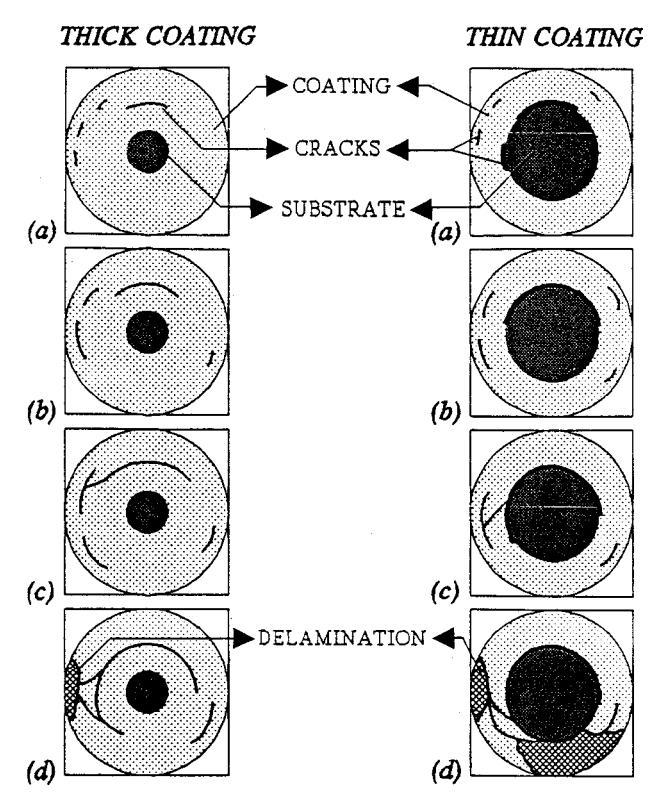
Fig. 13. Schematic of coating delamination process. (a, Initiation of cracks at the depths of maximum shear and orthogonal shear stress; b, propagation of cracks parallel to surface; c, combination of cracks; d, coating delamination.)

A schematic of this delamination process is shown in Fig. 13 for both thick and thin coatings. The figure summarises schematically the mechanism of delamination during the RCF tests based on the location and orientation of subsurface cracks. These observations indicate that the coating delamination was a subsurface failure mechanism resulting in macro-pitting of surface due to subsurface cracks which nucleated from coating defects. The subsurface investigations of the coated rolling elements which did not fail in delamination revealed no subsurface cracks. This showed that the coatings which did not delaminate actually resisted the subsurface cracking.

It is the authors' view that during the RCF test there was a competition between the two modes (surface wear and delamination) of failures. In the early stages of RCF tests, the contact stress was high and there was a high tendency towards delamination type failure. This can be appreciated from the test results (Table 1) in which delamination type failures were generally associated with lower RCF life. If the test conditions were such that the coating microstructure resisted this delamination failure in the early stages of RCF test, surface wear decreased the

tendency towards delamination type of failure in the later stages of RCF test. This was due to the decrease in contact stresses as a result of contact conformity brought about by the surface wear.
