Wear 257 (2004) 1103-1124

Sliding wear evaluation of hot isostatically pressed (HIPed) thermal spray cermet coatings

V. Stoica^a, R. Ahmed^{a,*}, T. Itsukaichi^b, S. Tobe^c

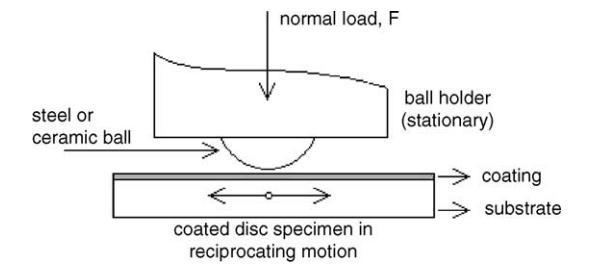
Fig. 2. High frequency reciprocating ball on plate rig.

Sliding wear tests were carried out using a reciprocating ball-on-plate apparatus, instrumented to measure the frictional force via a load cell (Fig. 2). As it can be appreciated from the figure, the upper ball bearing the normal load is stationary while the coated disc has a reciprocated motion. The sliding speed was 0.037 m/s at the centre of the wear scar. The type and properties of the balls are listed in Table 3. The coated specimens were ground and polished to produce a surface roughness (R_a) of 0.04 µm. Before each test, the coatings and balls were ultrasonically cleaned in acetone for 5 min to remove any contaminants and grease and then dried in air.

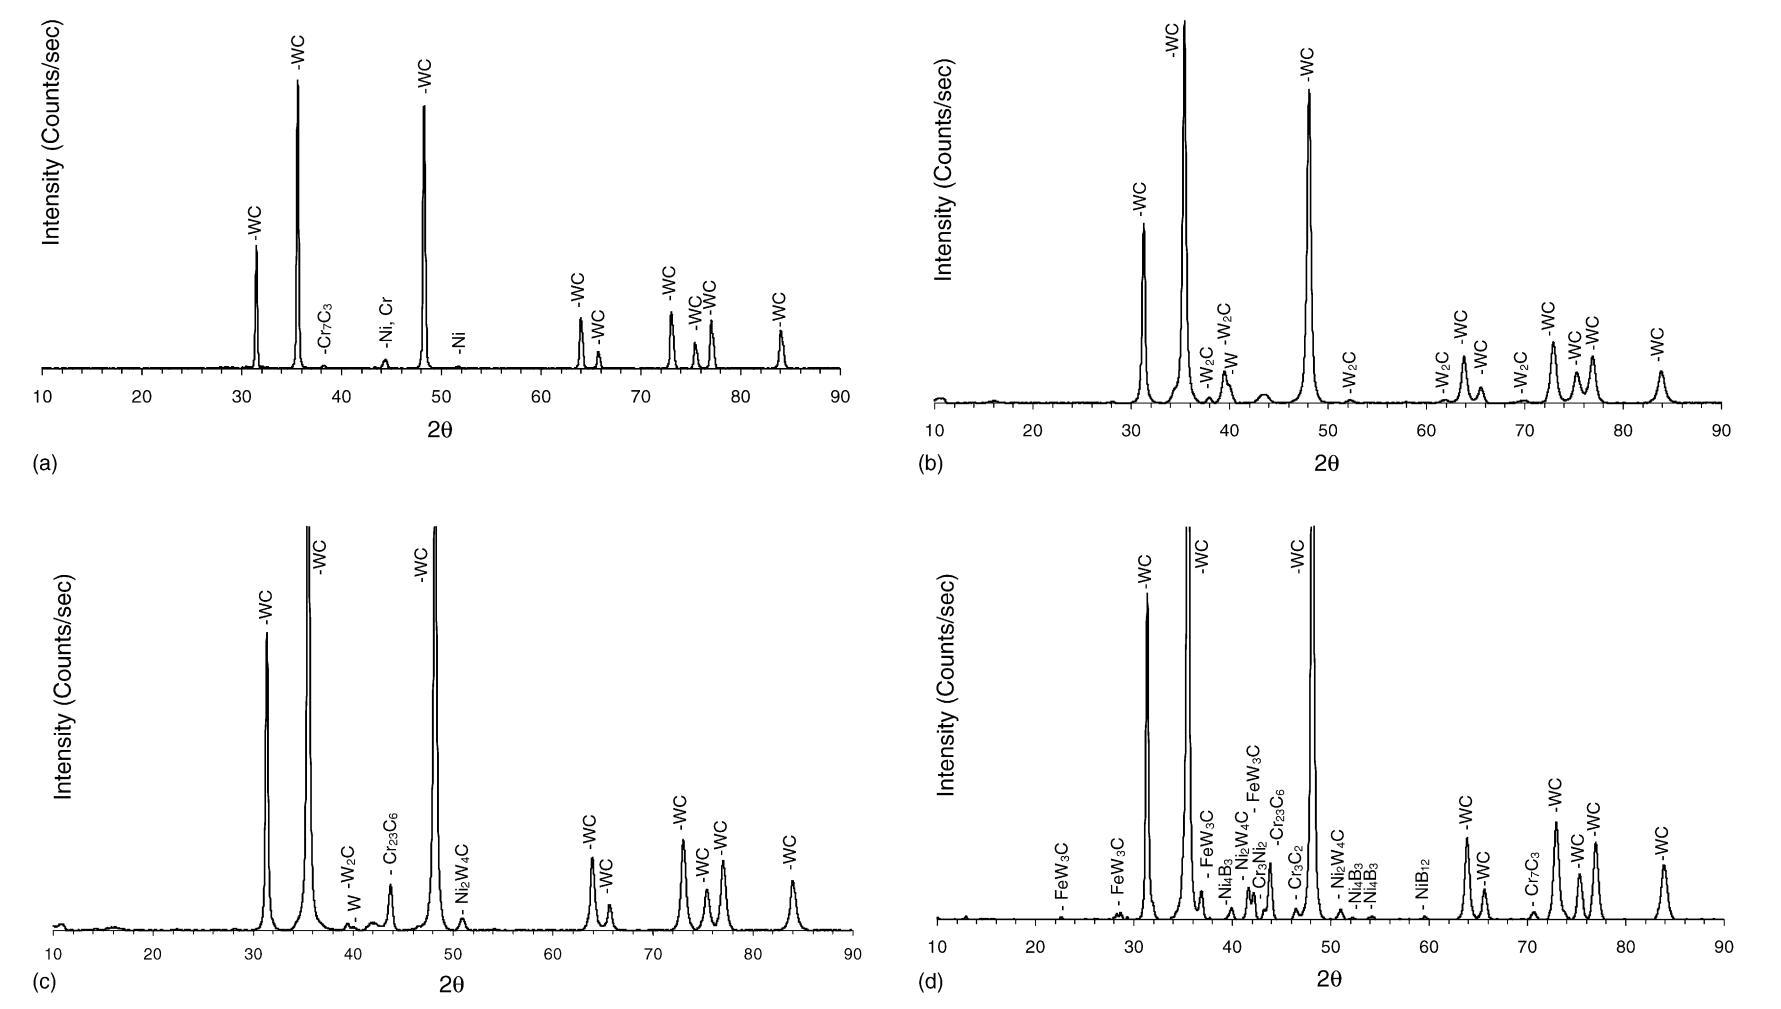
Fig. 3. XRD spectra of (a) WC-10 wt.% NiCrSiBFeC powder and top layer of (b) as-sprayed, (c) coating HIPed at 850 °C, and (d) coating HIPed at 1200 °C.

The XRD patterns of the spray powder, as-sprayed and HIPed coatings are presented in Fig. 3. Fig. 3a shows the phase composition of agglomerated and sintered WC-10 wt.%NiCrSiBFeC powders. As expected high amounts of mono tungsten carbide (WC) and certain quantity of metallic nickel and chromium can be observed in the powder spectra. However, beside these phases, some amounts of chromium carbides (Cr_xC_y) are also seen, which were brought about by the powder manufacturing process.

Deposition of these powders under the conditions listed in Table 2 led to the formation of secondary phase tungsten carbide (W₂C) and metallic tungsten (W). Further evidence of coating decomposition can be seen by the peak broadening between 42.7° and 44.7°, which indicates the presence of amorphous/nanocrystalline phase.

The post-treatment carried out at 850 °C produces visible changes in the coating phase composition (Fig. 3c). Thus, higher amounts of primary tungsten carbide, less amounts of secondary phase (W₂C) and metallic tungsten (W) are noticed. The occurrence of two additional phases, complex carbide containing Ni (Ni₂W₄C) and cromium carbide $Cr_{23}C_6$ is also observed.

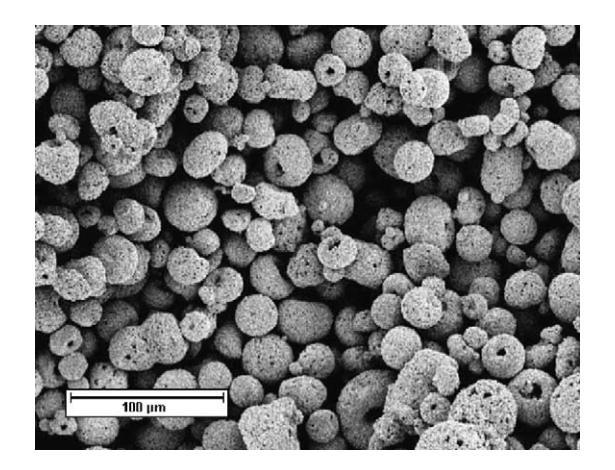
Fig. 4. SEM micrograph of the starting WC-10 wt.%NiCrSiBFeC powder.

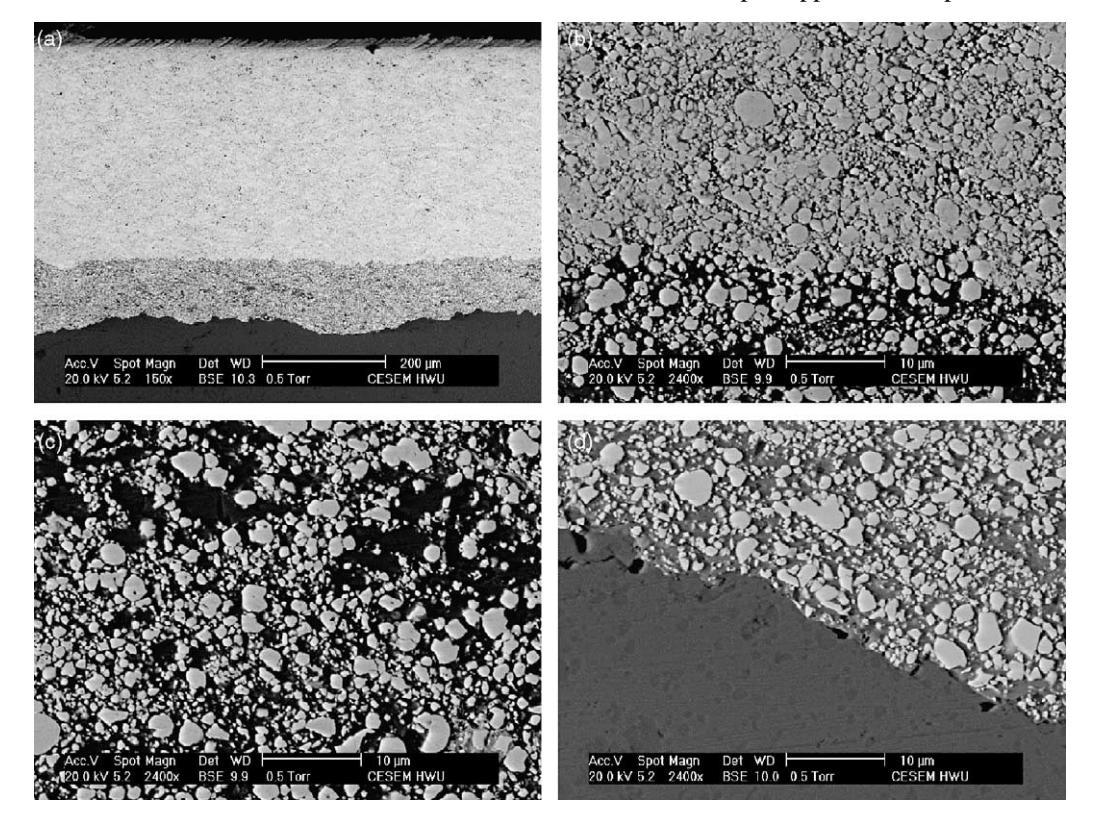
Fig. 5. SEM micrographs of the as-sprayed coating: (a) general view, (b) interface between top and bottom layers, (c) bottom layer, and (d) interface between the coating and the substrate.

Figs. 5–7 show SEM micrographs taken on the crosssection of the as-sprayed and HIPed coatings. Figs. 6d and 7d exhibit the interface between the HIPed coatings and the substrate. Contrary to the as-sprayed coating shown in Fig. 5d, an additional layer, slighly brighter than the matrix or the substrate, occurred, in both cases, along the interface. This layer is approximately 5 μ m for the coating HIPed at 850 °C and about 25 μ m for the coating HIPed at 1200 °C.

As illustrated in the Figs. 5b and d, and 6b and d, no clear evidence was observed of any effect of the post-treatment carried out at 850 °C on the size and shape of carbide grains. Thus, both the as-sprayed and the coating HIPed at 850 °C have approximately the same characteristics. This was valid for both the upper and bottom coating layers. Hence, 850 °C proved to be lower than the temperature needed to cause substantial changes thoughout the coating microstructure.

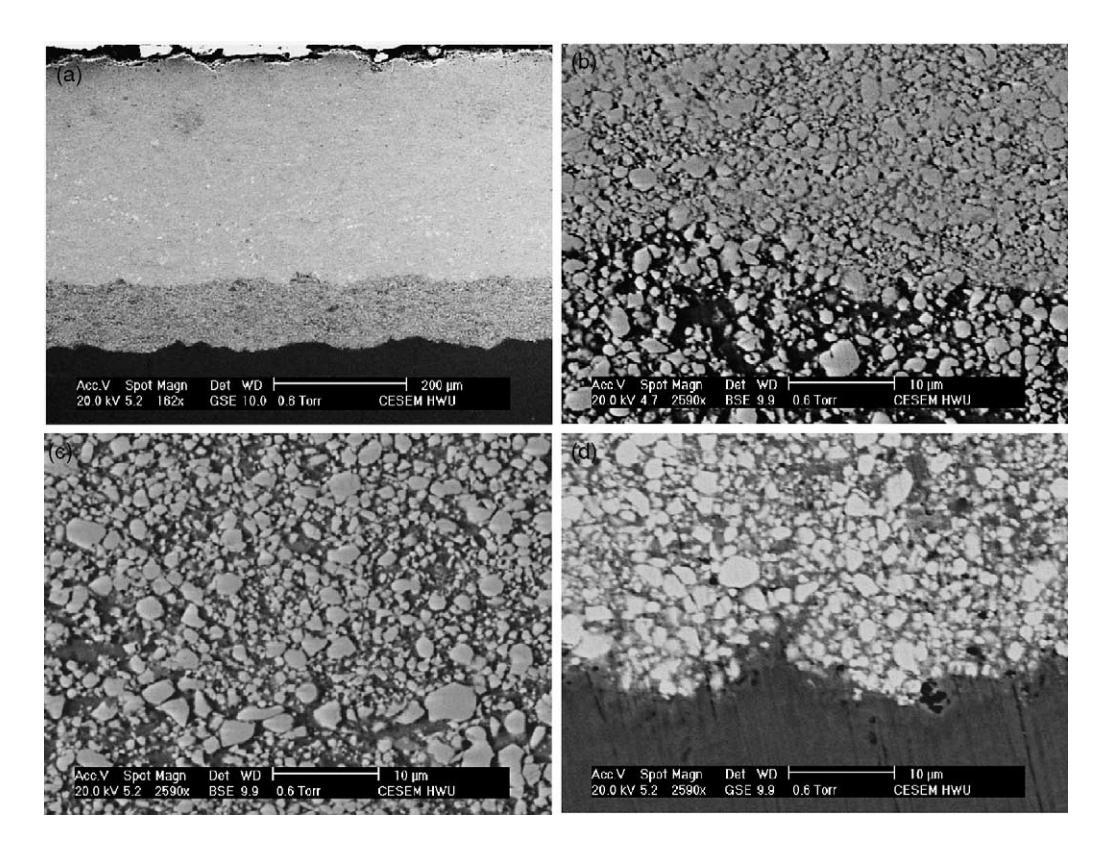
Fig. 6. SEM micrographs of the coating HIPed at 850 °C: (a) general view, (b) interface between top and bottom layers, (c) bottom layer, and (d) interface between the coating and the substrate.

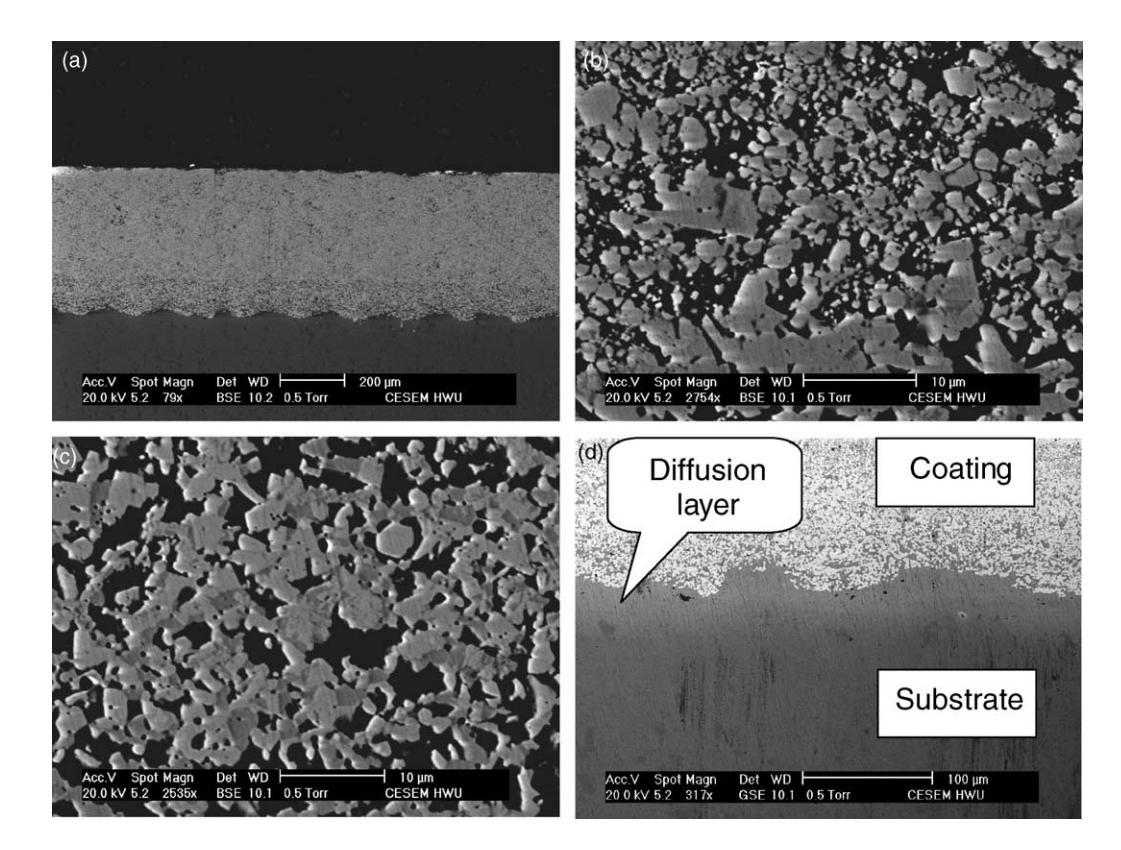
Fig. 7. SEM micrographs of the coating HIPed at $1200 \,^{\circ}$ C: (a) general view, (b) interface between top and bottom layers, (c) bottom layer, and (d) interface between the coating and the substrate.

shown in Figs. 5 and 6. However, the micrograph of the coating HIPed at 1200 °C shows significant changes in the structure of the coating. Throughout the coating, within both layers, the carbides underwent a transformation in the shape from rounded to prismatic. Moreover there was an obvious difference between the two coating layers. This is the presence of carbide agglomerates in the layer which has a higher level of binder. Hence, the carbide grains are dragged one to another and they form closely-packed islands which, as a result, increases the areas of matrix which do not contain carbide grains (Fig. 7c).

Finally, a closer look at the interface between the bottom and the upper layers of the coating HIPed at the temperature of $1200 \,^{\circ}\text{C}$ reveals the existence of another layer of a thickness of approximately $15 \,\mu\text{m}$. The structure of this intermediar layer is rather similar to that of the bottom layer of the coating HIPed at $850 \,^{\circ}\text{C}$ although the grains have the angular shape characteristic to the coating HIPed at $1200 \,^{\circ}\text{C}$ (see Figs. 6c and 7b).

Contrary to above, the post-treatment carried out at 1200 °C produced appreciable changes (Fig. 7). Firstly, noticeable throughout the coating is the tendency of the carbide grains to become prismatic. Moreover, under the pressure of the post-treatment a rearrangement of the grains is observed and thus a shift from a relatively homogenous distribution of

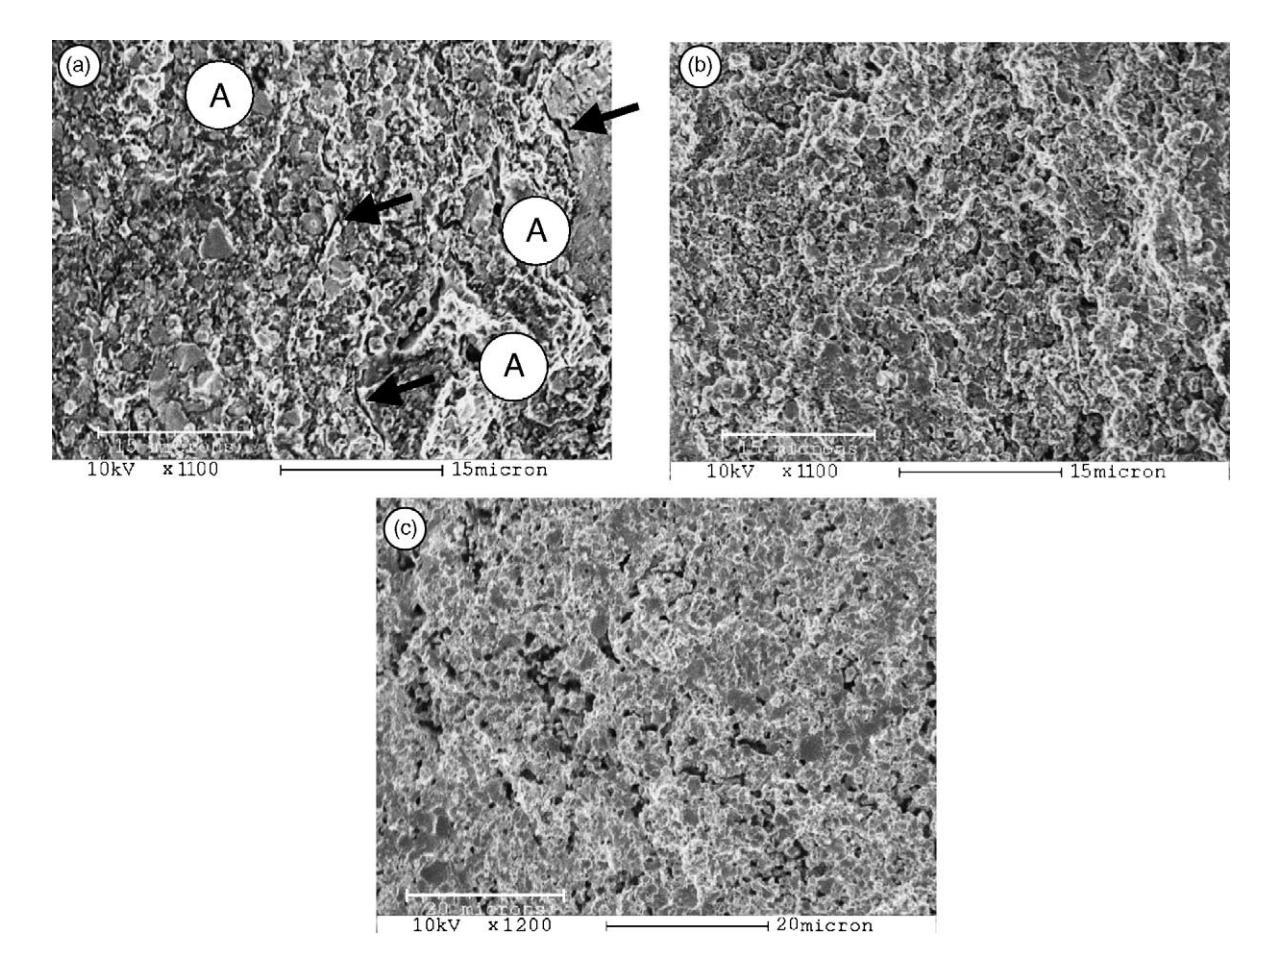
Fig. 8. SEM micrographs on cross-section of cryogenic fractured: (a) as-sprayed (the arrows indicate cracking, "A" indicates pores), (b) HIPed at 850 °C, and (c) HIPed at 1200 °C coatings (upper layer).

Thus, the gradual increase of the microhardness with HIPing temperature is brought about by the occurrence of new hard phases throughout the upper coating layer. The analysis of the phase composition also shows that an elimination of brittle phases takes place during the HIPing process, and is enhanced with increasing the temperature. Although only qualitative, the fracture toughness results show consistent behaviour confirming the above. Hence, there is an increase of the potential of the upper coating layer to withstand higher loads without fracturing with the temperature of the posttreatment. However, a simultaneous increase in the hardness and the toughness will not be reasonable without an improvement of the elasticity of the upper coating layer. The modulus results taken on the surface and throughout the cross-section of this layer of both HIPed coatings validated this assumption. Hence, it is believed that the transformations in the phase composition of the coatings during the post-treatment set up new relatively stronger bonds at 850 °C, which is reflected by the substantial increase in the elasticity of the HIPed coatings compared with the as-sprayed ones. However, the modulus results of the coating HIPed at 1200 °C shows even higher values. Although the coating HIPed at 1200 °C has higher modulus, the coating treated at 850 °C has lower modulus gradient, and hence almost no anisotropy. The source of the anisotropy might be the porosity level of the coatings HIPed at 1200 °C (Fig. 8c), which influences the measurements taken at low load of 500 mN.

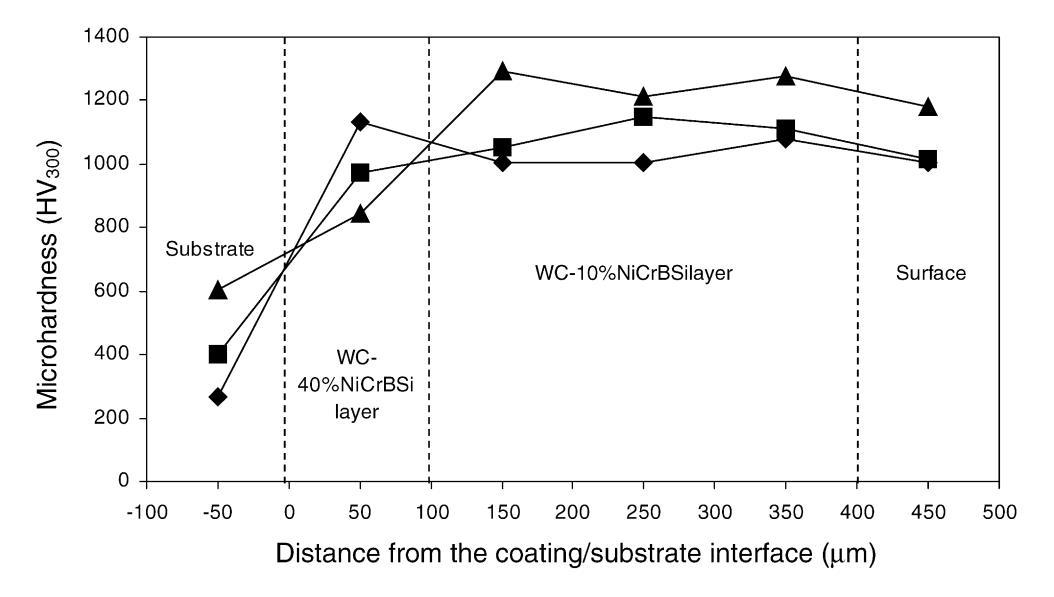
Fig. 9. Variation of coating microhardness with the distance from the coating/substrate interface. () as-sprayed, () HIPed at 850 °C, () HIPed at 1200 °C.

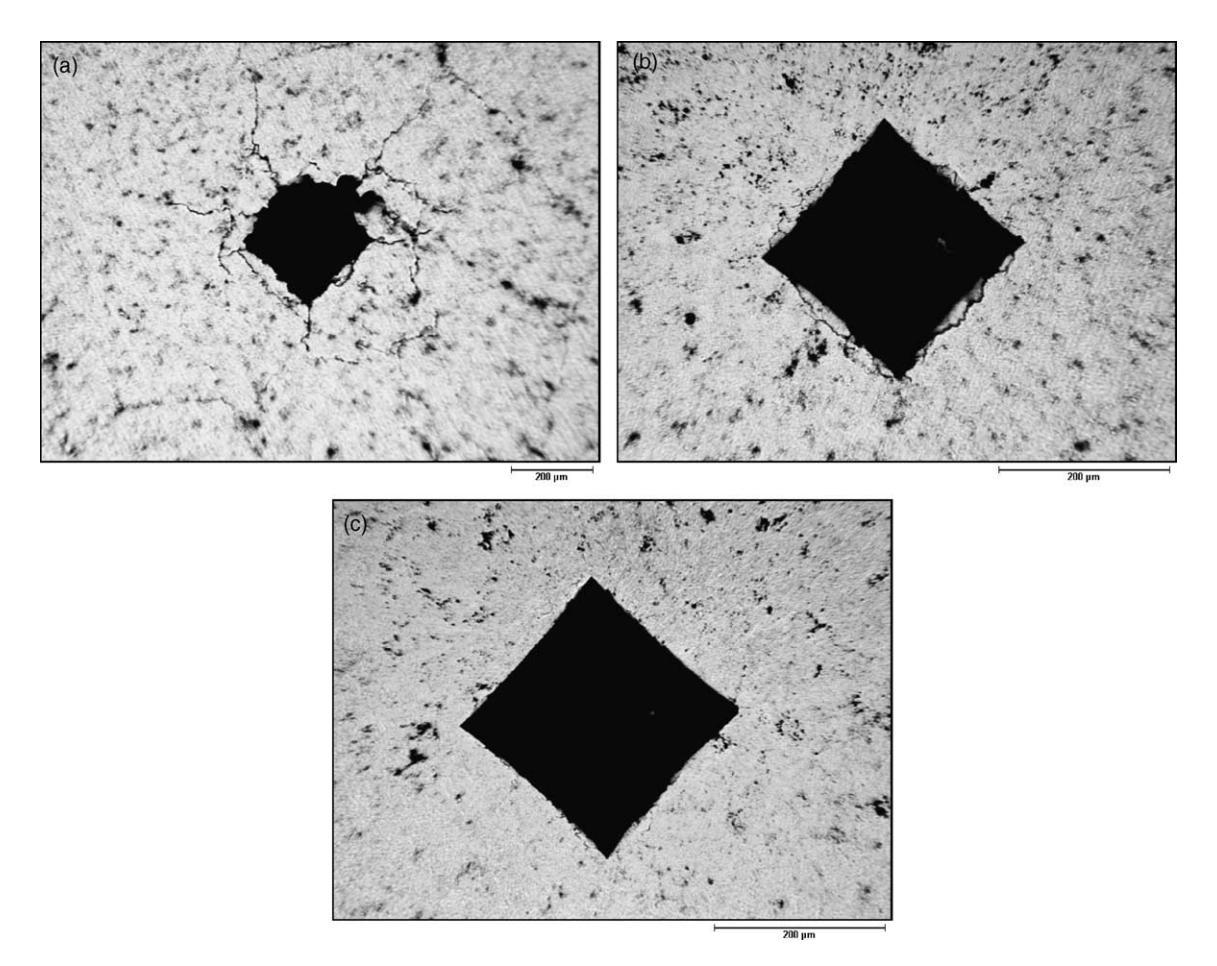
Fig. 10. Fracture toughness indentations on (a) as-sprayed, (b) HIPed at 850 °C, and (c) HIPed at 1200 °C coatings (all coating tested at 50 kg).

analysis of the fracture toughness could not be performed. Therefore, using the micrographs taken with an optical microscope (Fig. 10), only qualitative observations on the coating fracture mode could be made.

The micrograph of the as-sprayed coating (Fig. 10a) shows a net of cracks spread around the indentation. The cracks originated not only from the corners but also from the each side of the indentation, propagating randomly in the surroundings. Differing, the indentations of the coating HIPed at 850 °C exhibit less cracks, limited only in the close vicinity of the indentations. The coatings HIPed at a temperature of 1200 °C produced tougher coatings, conclusion drawn after analysing all the indented coatings. As Fig. 10c reveals, no cracks were produced indenting the coatings with a load as high as 50 kg.

come unstable at temperatures above $850 \,^{\circ}$ C. It is believe that reactions of these phases with the existent nickel or iron from the matrix led to the formation of additional complex carbides (Ni₂W₄C, FeW₃C). The increased intensity of the WC peaks suggests that some secondary phase also converted to WC, conversion facilitated by the carbon which existed in the matrix (Table 1). Thus, although there are still some brittle secondary phases of tungsten carbide in the coatings HIPed at 850 °C, they are less than in the as-sprayed coating. Therefore, these post-treated coatings can be expected to be tougher. Moreover once the complex carbides formed, they should bring extra hardness to the coatings HIPed at 850 °C. Their influence on toughness can also be appreciated from Fig. 10.

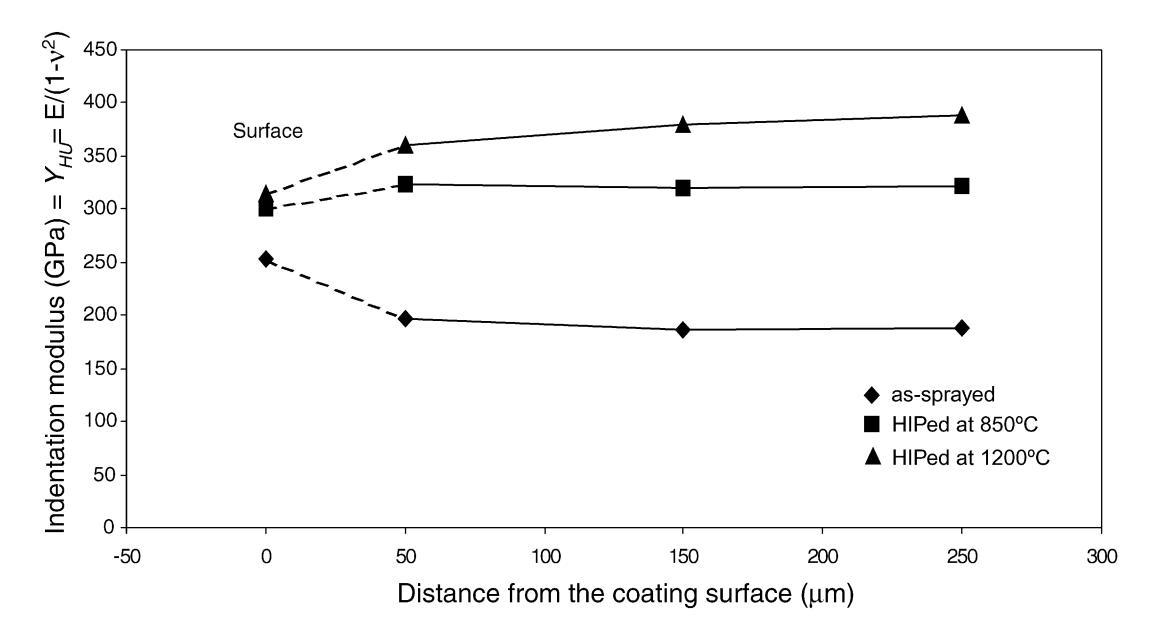
Fig. 11. Variation of coating elasticity with the distance from the coating surface.

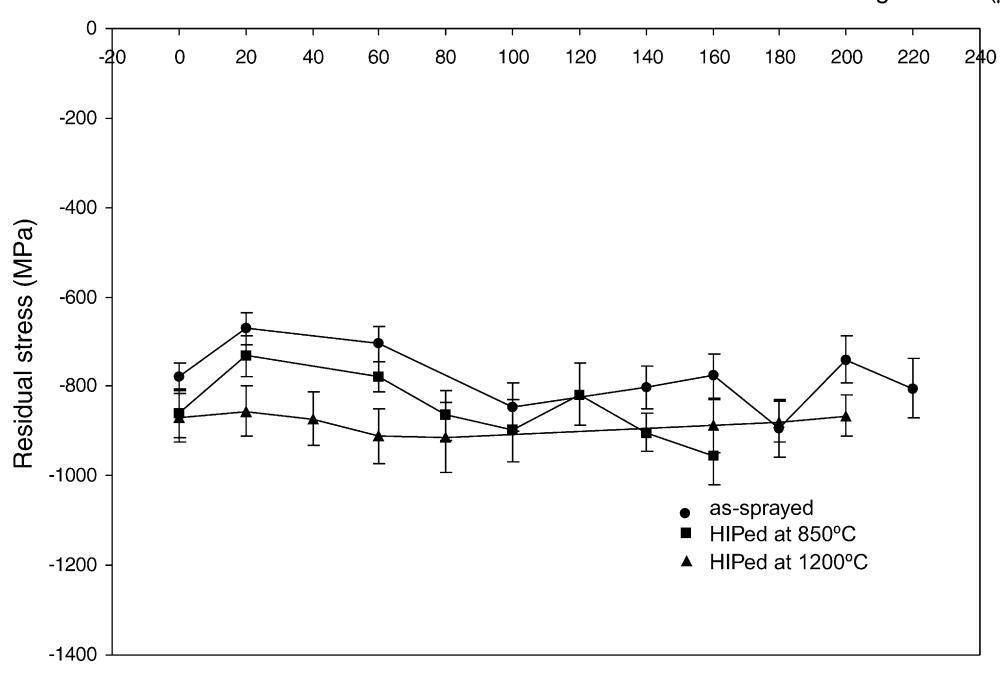
Fig. 12. Variation of coating residual stress with the distance from the surface.

The results of residual stress measurements are summarized in Fig. 12, which describes how the residual stress changes when the coatings are post-treated by the HIPing process. Firstly, as expected the residual stress of all coatings is compressive. Secondly, it is observed that HIPing the coatings at 850 °C leads to an increase in compressive stress of about 9%, from 780 MPa to approximately 850 MPa. HIPing the coatings at 1200 °C further increases the stress to 990 MPa. All these values were calculated by averaging the residual stress over the coating thickness. In terms of stress gradient along the coating thickness, no difference is noted between the stress distributions of the as-sprayed and HIPed at 850 °C coatings. Both these coatings exhibit in some regions stress variations of almost 100 MPa across a thickness of 20 μ m. On the other hand, the coating HIPed at 1200 °C has a maximum variation of approximately 50 MPa, which is spread over the first 60 μ m.

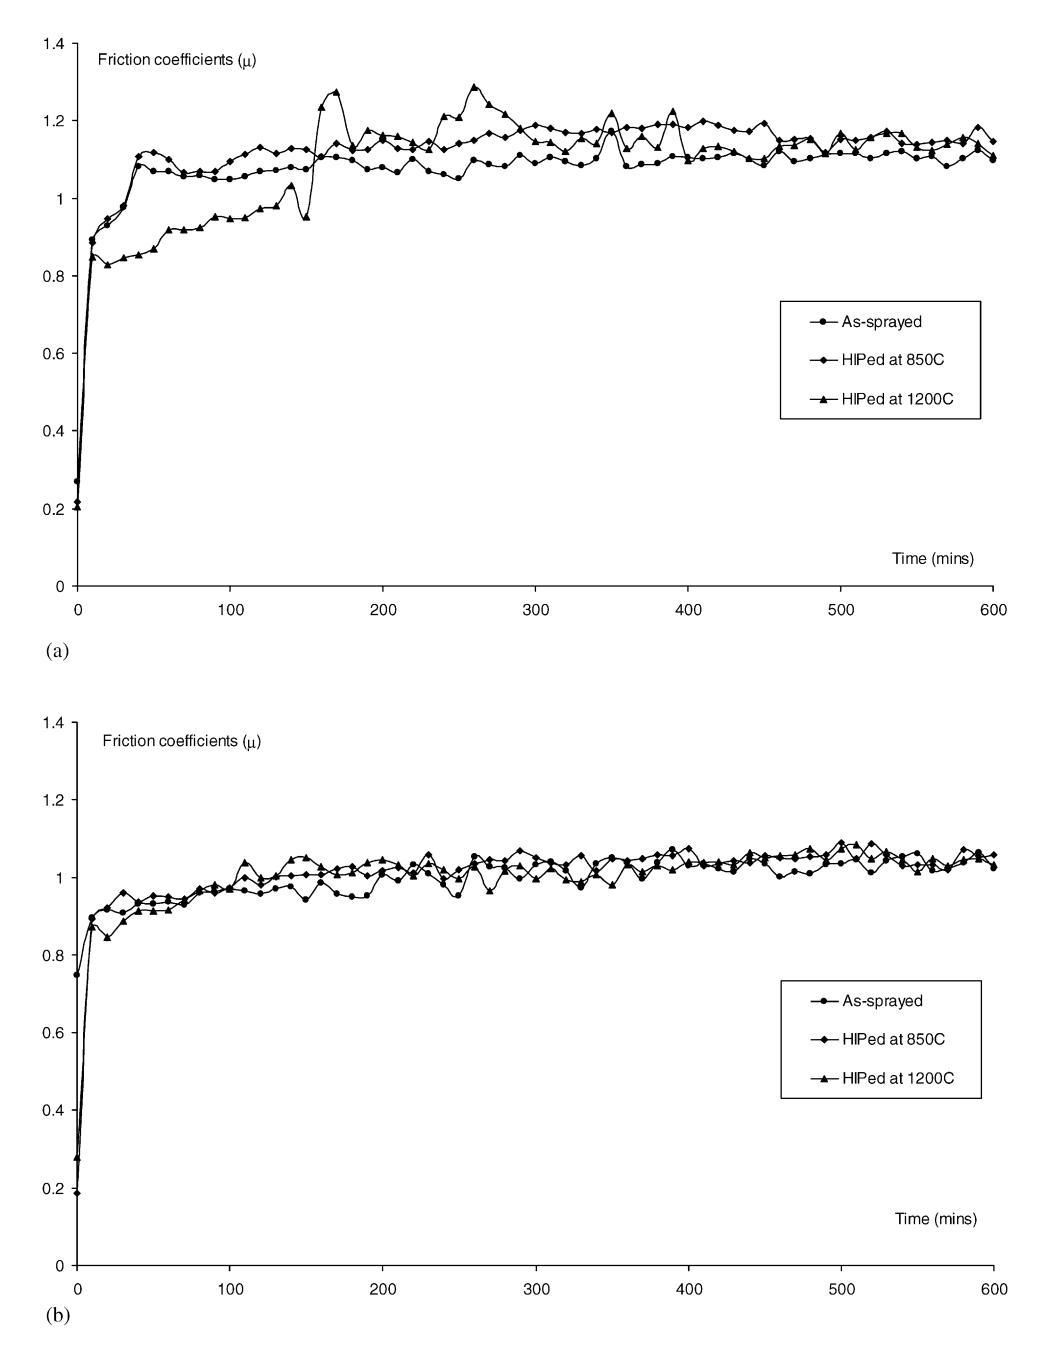
Fig. 13. Friction coefficient of the as-sprayed and HIPed coatings tested vs. (a) 440C steel and (b) Si_3N_4 balls (load = 12 N).

The friction coefficients of all tested couples are presented in Figs. 13 and 14. Fig. 13a and b shows the friction behaviour of the couples tested using the lower load. The online measurements indicated higher frictional force for all coatings tested against steel balls compared with coating–ceramic couples. Correspondingly, as shown in the above-mentioned figures, the friction coefficients are higher, with averaged values of 1.13 and 1.03, respectively.

Comparing Fig. 13a with 14a and thus, the friction coefficients produced sliding steel balls over the coatings, it is observed that the tests carried out at a load of 22 N produces less friction than those using lower load. The average value of friction coefficient decreases from 1.13 to 0.87 with increasing load from 12 to 22 N. The same trend is given by the graphs in Figs. 13b and 14b. Thus, the average friction coefficient of the coating–ceramic couples is 1.03 and 0.94 for low and high load, respectively.

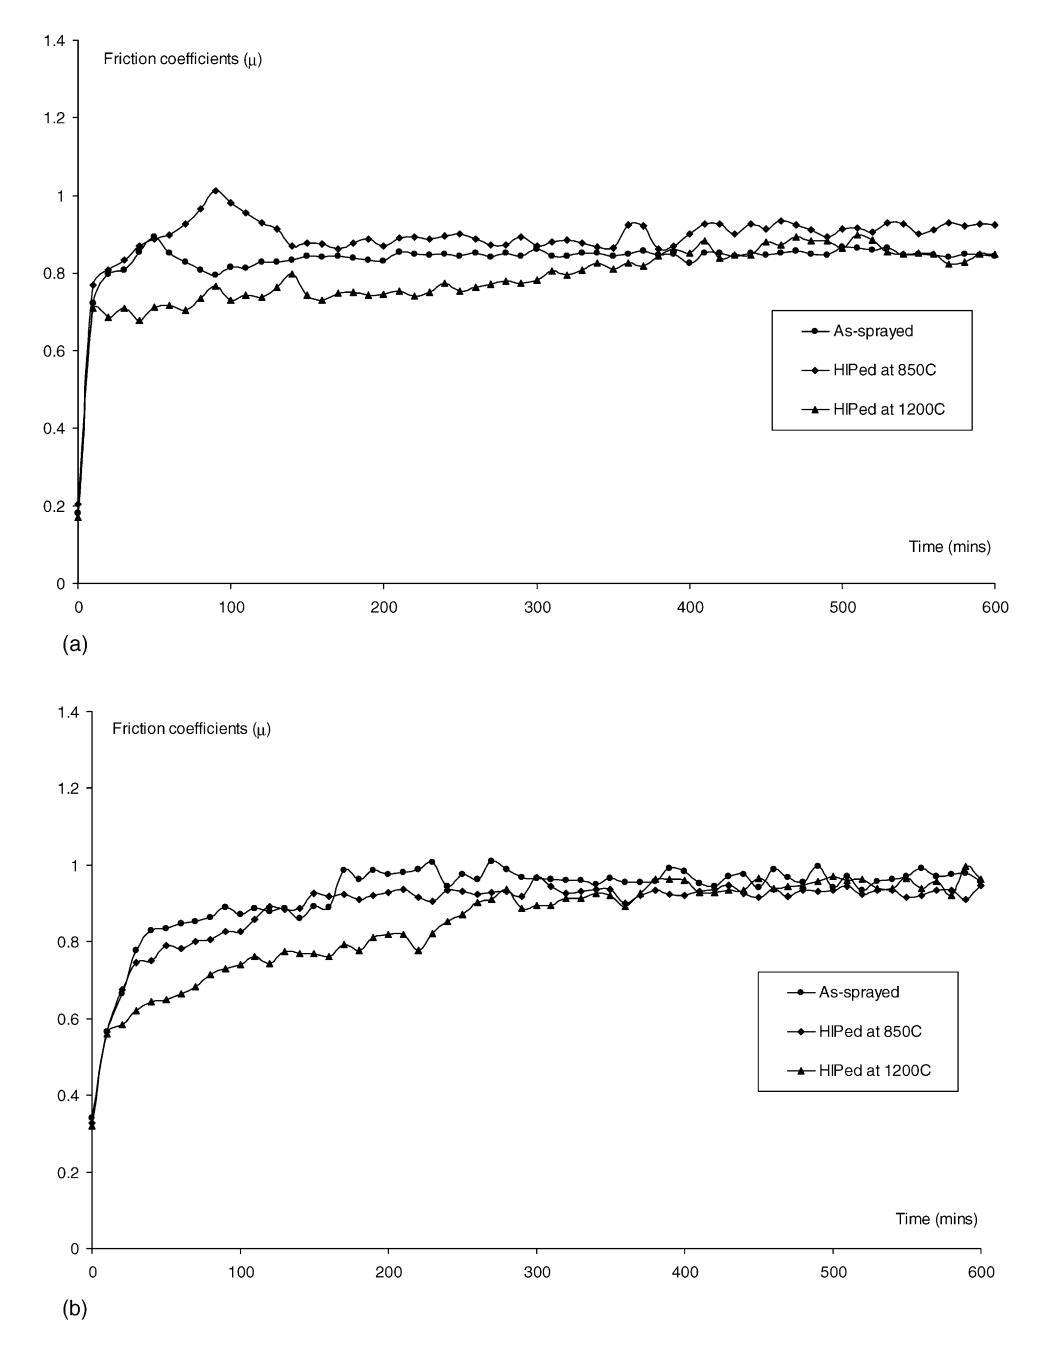
Fig. 14. Friction coefficient of the as-sprayed and HIPed coatings tested vs. (a) 440C steel and (b) Si_3N_4 balls (load = 22 N).

When the balls applies 22 N on the coating, contrary to the above case, the frictional force resulted from coating–steel contact is smaller than that produced by the coating–ceramic couples. This is shown in Fig. 14a and b where the friction coefficient of the couples involving steel have a value of 0.87 compared with 0.94 obtained rubbing the ceramic balls on the coatings. Summarizing this steel–ceramic comparison, regardless of the type of coating used, at low load (12 N) steel produces higher friction while, at high load (22 N), higher friction is given by the ceramic.

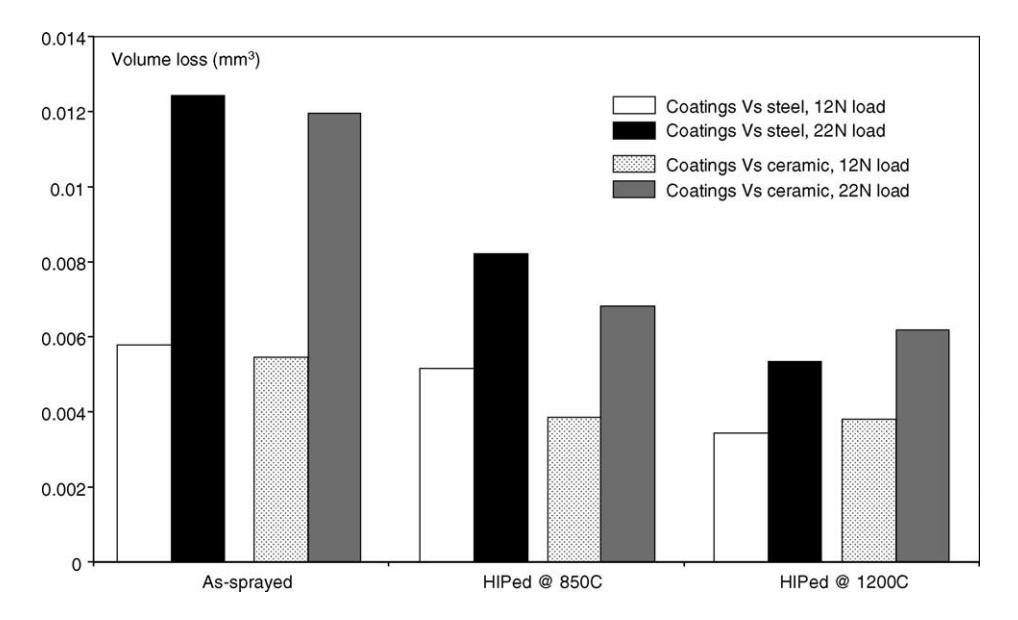
Fig. 15. Coating volume loss (mm³).

The general trend, regardless of the corresponding counterface or the load used, is that the HIPed coatings lost less material than the as-sprayed ones. This essential finding is shown in Fig. 15. Although no significant improvement in the wear resistance of the coatings HIPed at 850 °C can be noticed, the coating HIPed at 1200 °C loses almost half the material lost by the as-sprayed coatings. In this case, the performance of the coating HIPed at 850 °C is rather an exception. The rest of the couples show almost twice the wear resistance of the coatings HIPed at 850 °C, followed closely by the coating HIPed at 1200 °C.

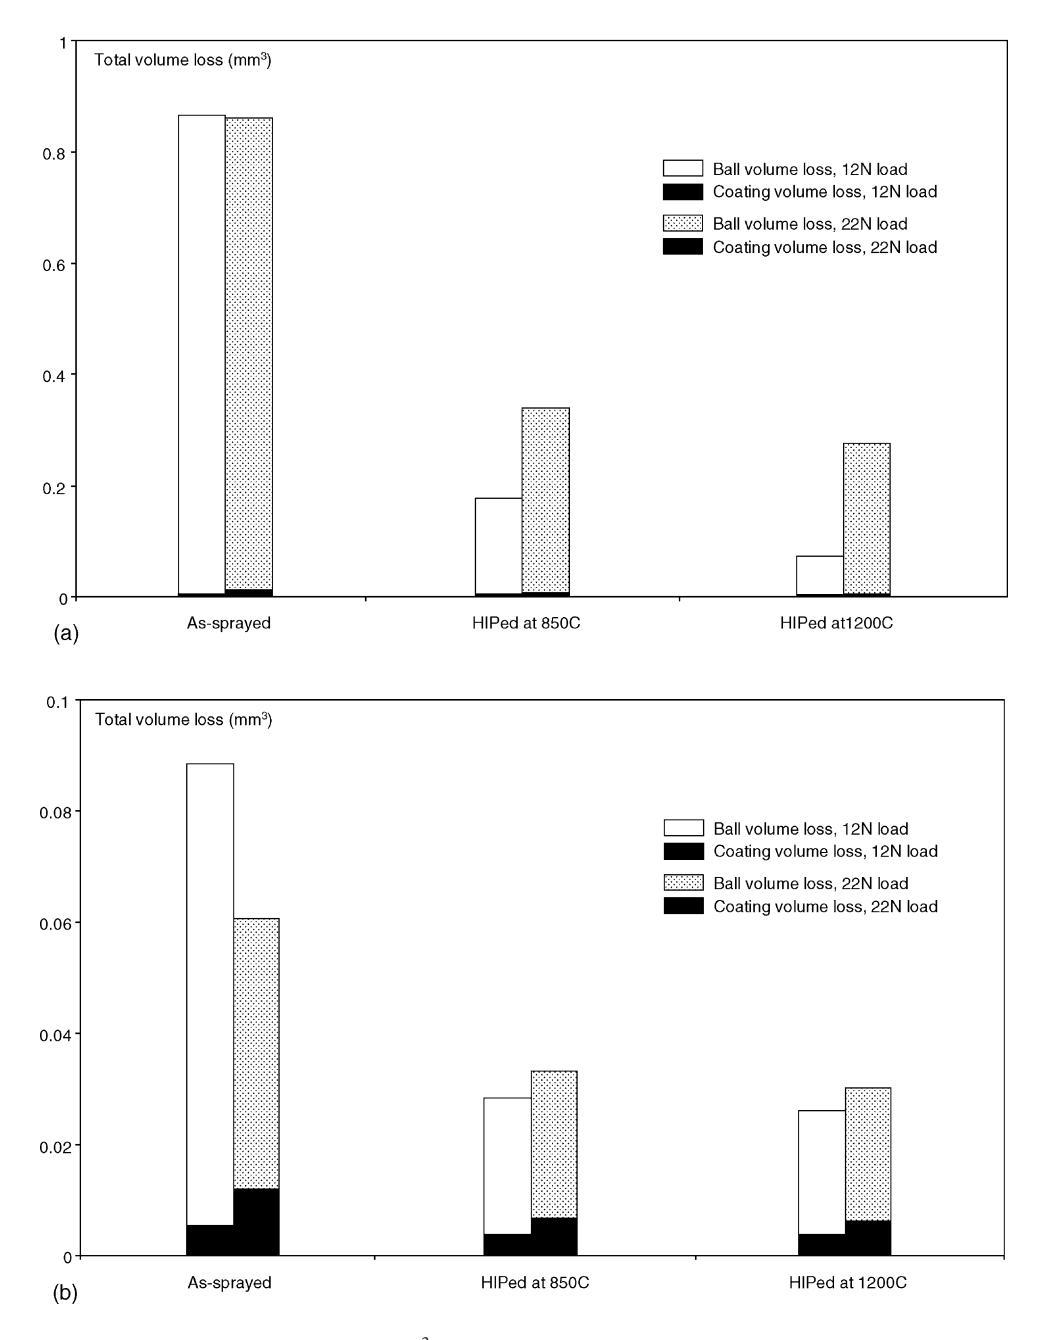
Fig. 16. Total volume loss (mm³) of (a) coating-steel and (b) coating-ceramic systems.

Adding the volume loss of the balls gives the total volume loss of the tested systems. Fig. 16 confirms furthermore the trends shown in the previous figure. Here the amount of the ball material lost during testing accentuates the difference between the as-sprayed and the HIPed coatings. Thus, in most cases, the ball which rubs on the as-sprayed coatings produced double or even more system material loss. This behaviour is consistent at both loads and also with steel and ceramic balls, indicating the consistent trend of improved wear performance over the range of tribological conditions considered in this investigation.

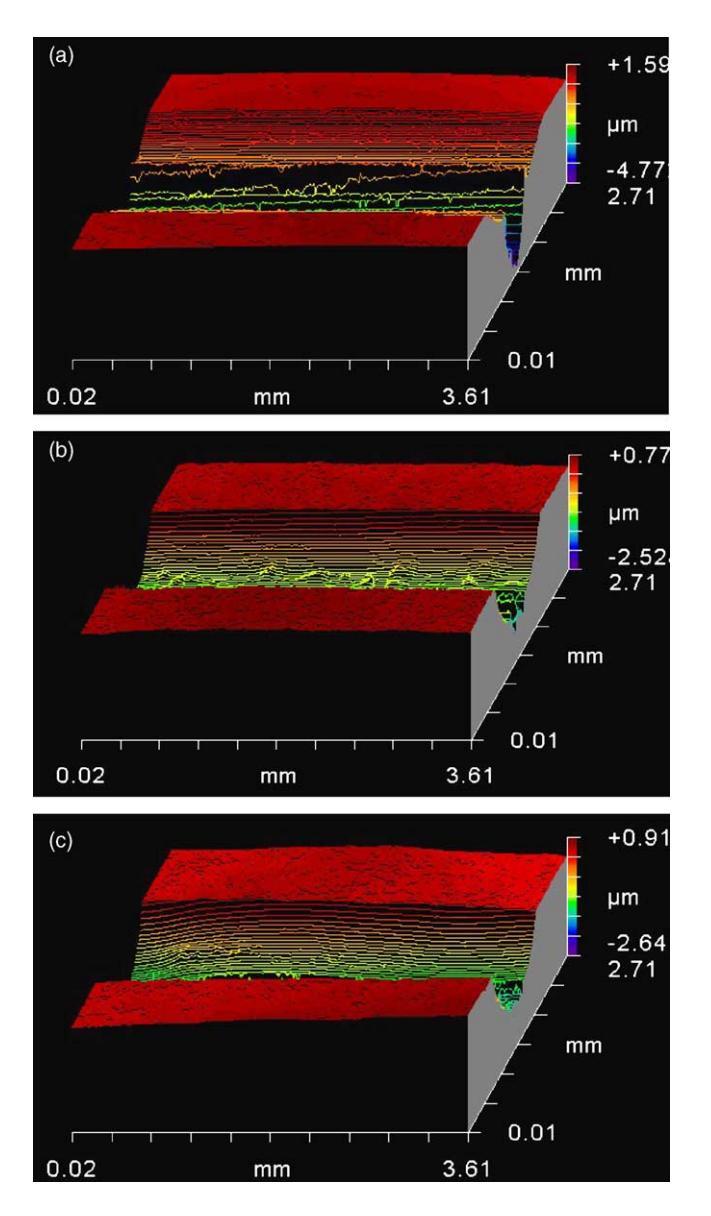
Fig. 17. Interferometric plots of the (a) as-sprayed, (b) HIPed at 850 $^{\circ}$ C, and (c) HIPed at 1200 $^{\circ}$ C coating wear scars produced by ceramic balls (load = 22 N).

The interferometric plots also provided three-dimensional plots of the middle section of coating wear scars. Some of them, those which were tested against ceramic balls under 22 N are presented in Fig. 17. The particularities of each coating wear scar such as width or depth can be observed from this figure. As a general trend, the scars on the as-sprayed coatings are significantly wider than those on the HIPed coatings.

In most cases the wear scars on the coating HIPed at $1200 \,^{\circ}$ C is the narrowest of them. In terms of wear track depth, the as-sprayed coatings are again the worst, being the deepest regardless the load or ball used. Quantifying for the couples presented in Fig. 17, the wear track on the as-sprayed coating has 5.8 µm depth and 1.6 µm width. Compared to this, the depth of the HIPed coatings wear scars is less than half, 2.25 µm and 1.8 µm, respectively. Same trend was seen when comparing the width of these coatings although the difference between the coatings is less. Thus, the width of the coating HIPed at 850 °C is 1.4 µm whilst that of the coating HIPed at 1200 °C is 1.38 µm.

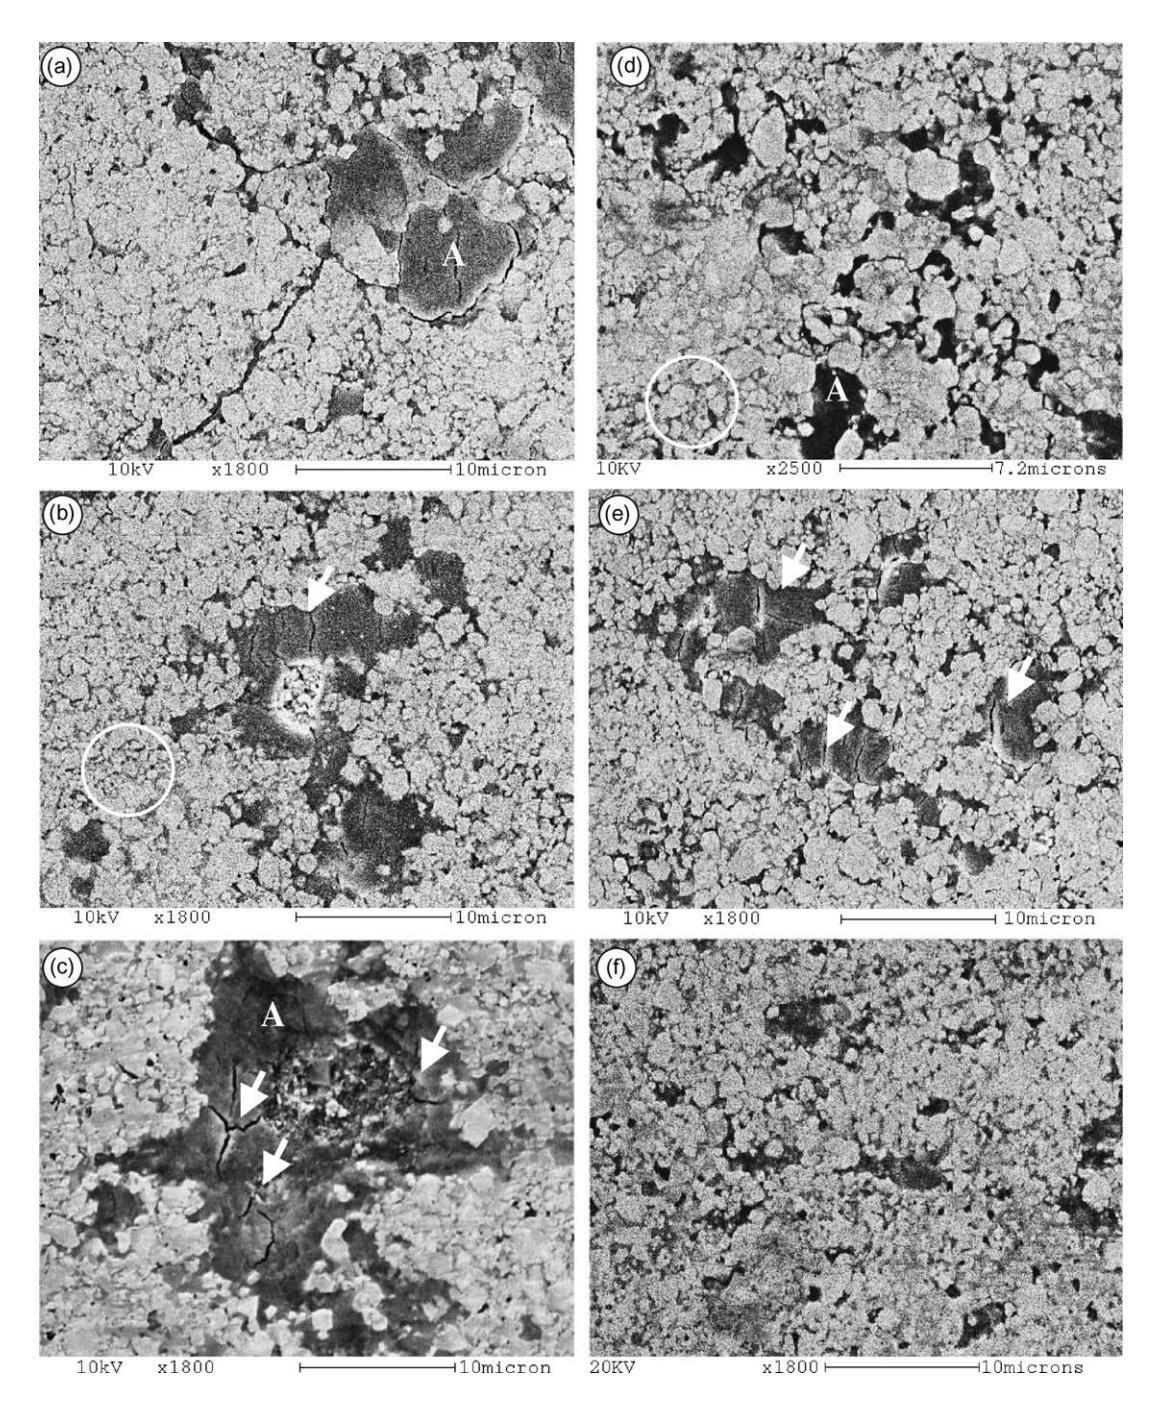
Fig. 18. SEM micrographs within the wear scar of as-sprayed, HIPed at $850 \,^{\circ}$ C and HIPed at $1200 \,^{\circ}$ C coatings tested against steel: (a), (b), (c), and ceramic (d), (e), (f) under a load of $12 \,$ N. ("A" indicates oxide layers and the arrows indicate cracking of the oxides under the load).

Fig. 18 summarizes the post-test investigations of the wear tracks of the as-sprayed and HIPed coatings which slid against steel and ceramic balls, whereas the debris resulting from sliding wear tests are shown in Fig. 19. Fig. 20 shows the EDX analysis within the wear track of the as-sprayed coatings.

Transient flash temperatures at the asperities contact lead to oxidation throughout the contact area. Hence, layers of dark phase (Fig. 18), confirmed by EDX to have high proportion of iron and oxygen, and tungsten (Fig. 20a and b) randomly covered the coatings tested against steel and ceramic. This suggests the presence of FeO in the first case (steel ball) and WO₃ in the later (ceramic ball). Since smearing of the oxide layer was noticed under the SEM, it is suggested that further sliding causes the spreading of the oxide layers over the coating. They also deposit into the surface pits providing reservoirs for further system solid lubrication, decreasing the friction coefficient and thus avoiding adhesive wear. Subsequent formation and removal of these oxide layers is a part of this process which last for the entire duration of the wear tests. Also called the oxidational wear, this process influences the total wear of the systems regardless of the load used. Cou-

ple of mechanisms by which the oxides can be detached as wear debris are proposed. Cracking is one of them, as shown in Fig. 18b, c, and e. Thus, the small thickness and also the brittleness of these layers cause their removal from the coating surface under the load. During sliding, this mechanism operates in sequence or simultaneous with other mechanisms involved. The spalling of some layer fragments exposes the coating which is prone to further wear by other wear mechanisms. Harder debris, removed either from the coating or from the ceramic ball will also be present in the contact area, and thus promote another mechanism for the detachment of the oxide layers. This is the rolling and sliding of the debris particles between the sliding surfaces, which once again led to cracking and spalling of the oxides. Once the oxide layer is removed, the amount of system material loss and also the increase in friction depend on the rapidity of the formation of new layer.
