Wear 257 (2004) 1103-1124

Sliding wear evaluation of hot isostatically pressed (HIPed) thermal spray cermet coatings

V. Stoica^a, R. Ahmed^{a,*}, T. Itsukaichi^b, S. Tobe^c

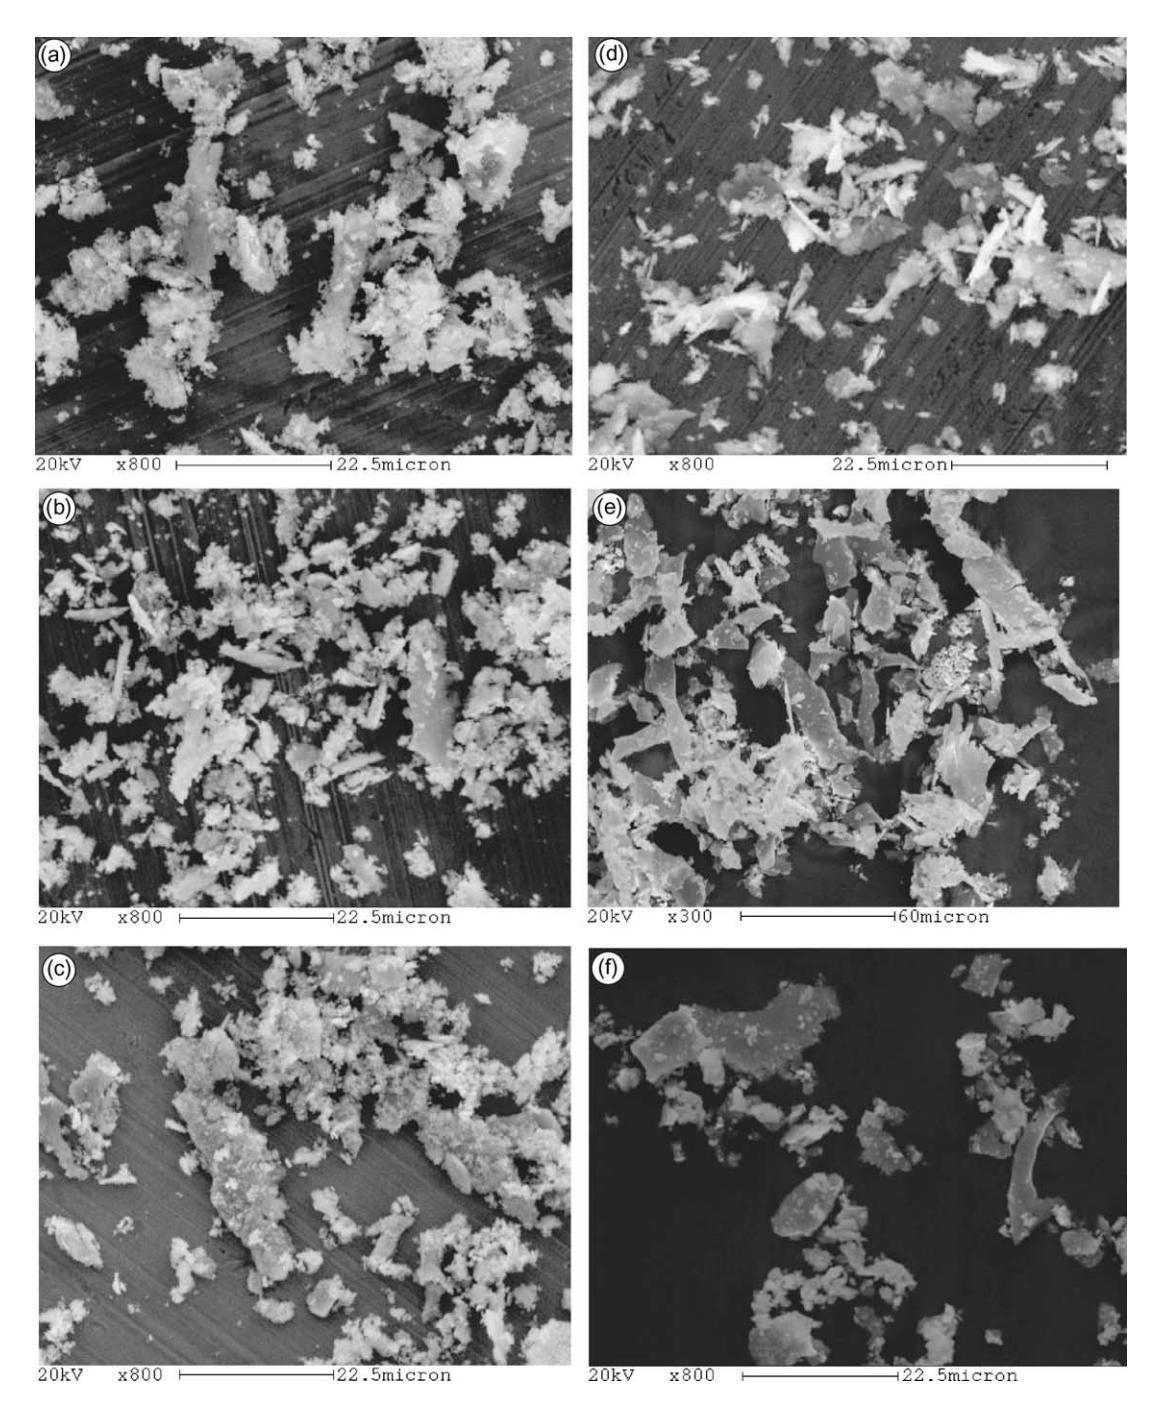
Fig. 19. Debris formed by sliding the as-sprayed, HIPed at 850 $^{\circ}$ C and HIPed at 1200 $^{\circ}$ C coatings against steel: (a), (b), (c), and ceramic balls (d), (e), (f) (load = 12 N).

Fig. 18 summarizes the post-test investigations of the wear tracks of the as-sprayed and HIPed coatings which slid against steel and ceramic balls, whereas the debris resulting from sliding wear tests are shown in Fig. 19. Fig. 20 shows the EDX analysis within the wear track of the as-sprayed coatings.

Although the examination of the wear debris collected at the end of wear tests doesn't give indications of its appearance at the formation, some suggestions on the transformations they suffer from the initial to the final state can be proposed. Thus, flake-like debris was found in most of the tests but also agglomerates of smaller particles, as shown in Fig. 19a. Elemental analysis on flakes-like debris produced in different tests suggest that they have oxide layers. They spalled out of the coatings and were involved in three body abrasive wear which cracked and fragmented them until they reached the sizes seen in Fig. 19. On the other hand, during sliding, particles detached from either the coating or the ball adhere to each other until agglomerates of different sizes form. They can move away from the contact area or get entrapped between the sliding pairs, becoming flattened by the plastic deformation. Although not included in this paper, elemental analysis of the debris indicated a combination of coating fragments, bits of oxide layer and ball material.

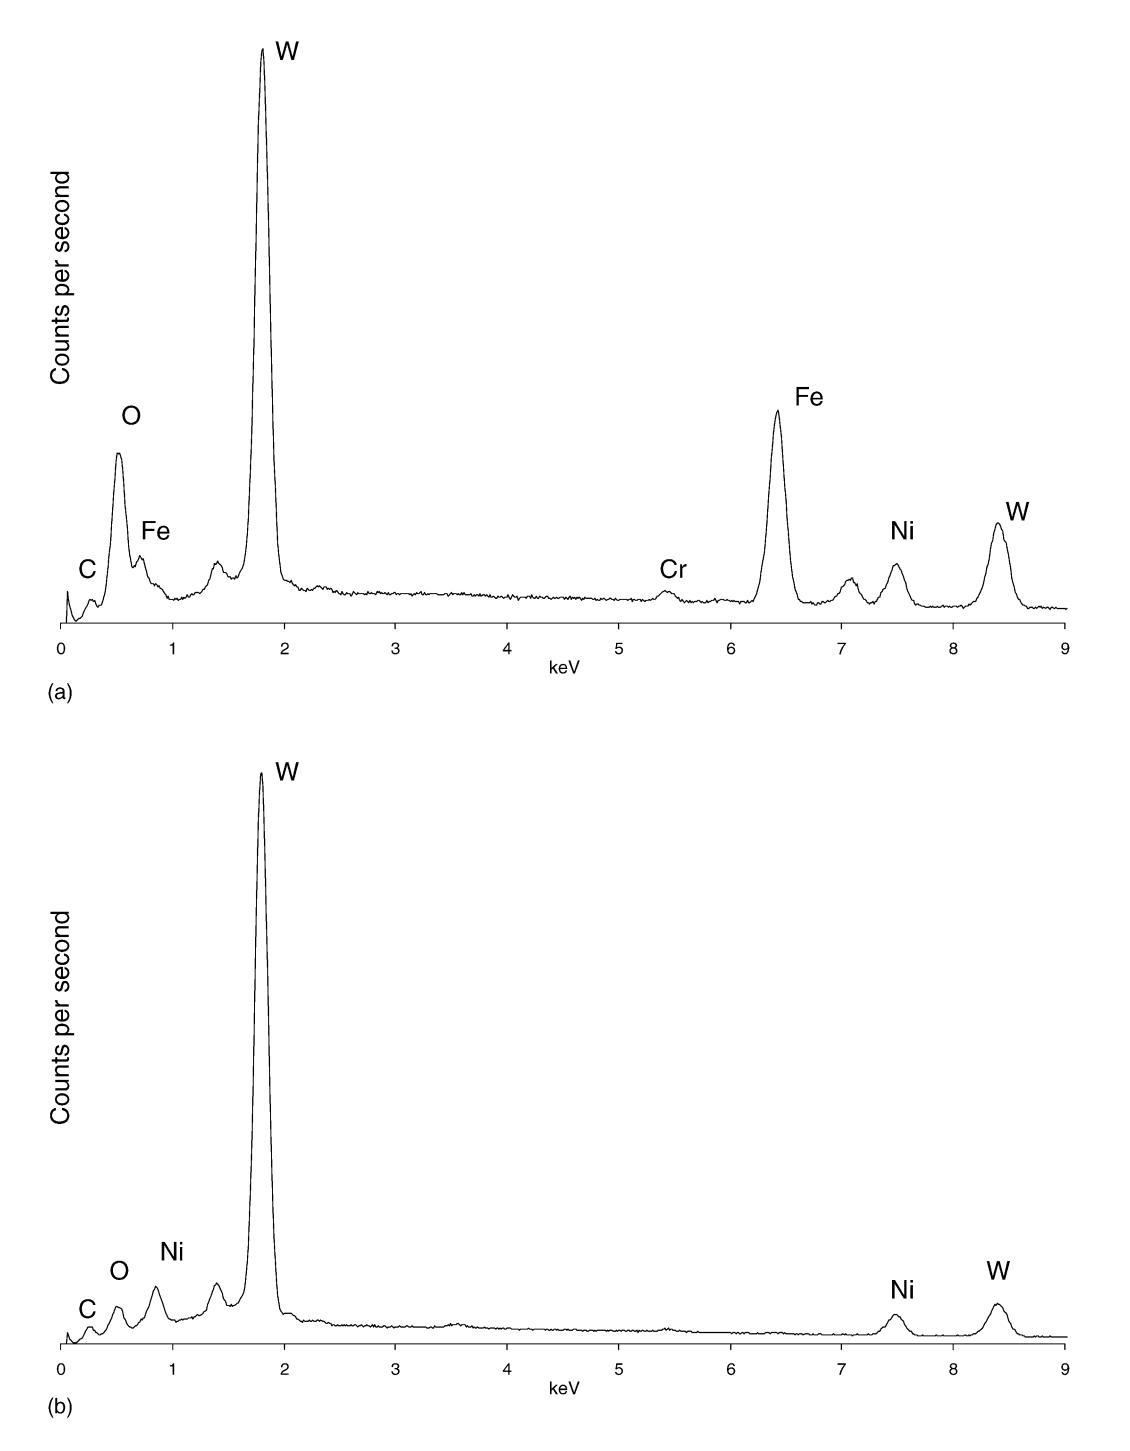
Fig. 20. EDX analysis within the wear scar of the as-sprayed coating tested against (a) steel and (b) ceramic ball (load = 12 N).

Transient flash temperatures at the asperities contact lead to oxidation throughout the contact area. Hence, layers of dark phase (Fig. 18), confirmed by EDX to have high proportion of iron and oxygen, and tungsten (Fig. 20a and b) randomly covered the coatings tested against steel and ceramic. This suggests the presence of FeO in the first case (steel ball) and WO₃ in the later (ceramic ball). Since smearing of the oxide layer was noticed under the SEM, it is suggested that further sliding causes the spreading of the oxide layers over the coating. They also deposit into the surface pits providing reservoirs for further system solid lubrication, decreasing the friction coefficient and thus avoiding adhesive wear. Subsequent formation and removal of these oxide layers is a part of this process which last for the entire duration of the wear tests. Also called the oxidational wear, this process influences the total wear of the systems regardless of the load used. Cou-
